Materials FA Investigation of a Semiconductor Laser Diode package with SEM FIB EDS and correlation with the Feedback Oxidation Loop of FA literature

Lasertel, Inc., Tucson, Arizona. *MACFA Consultant, **President, ***VP

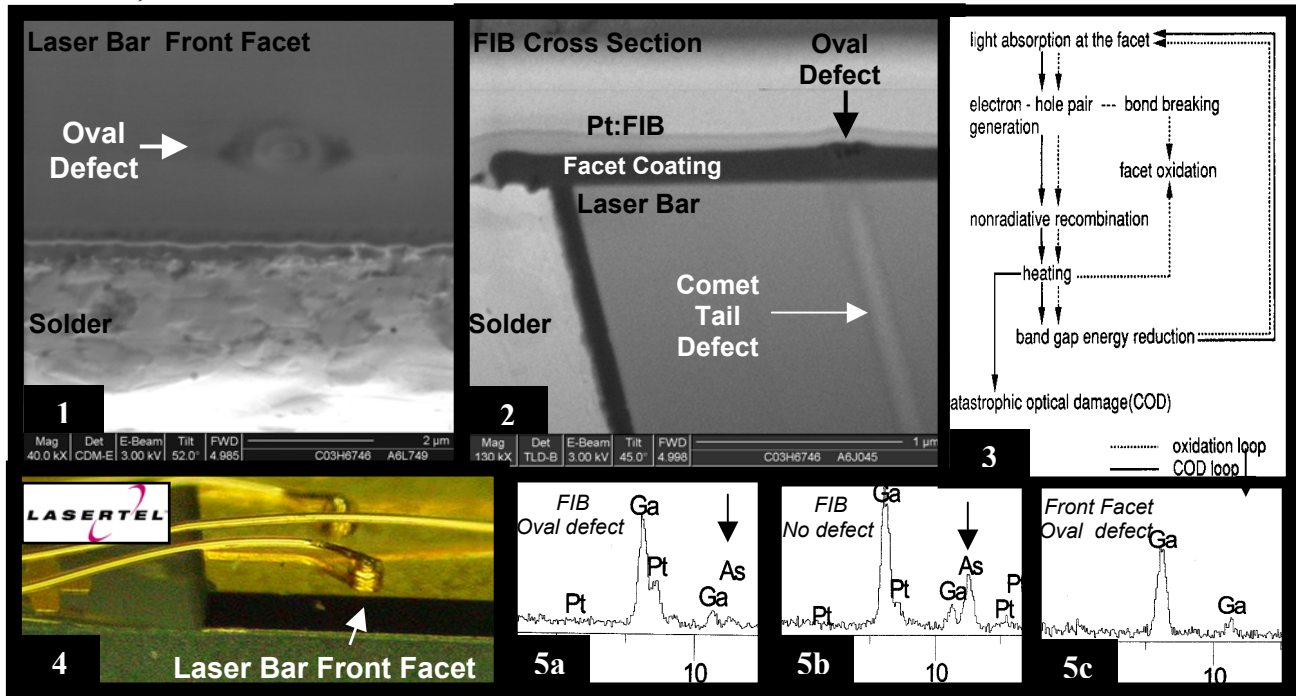
SEM investigation of the front facet coating of the semiconductor laser bar revealed an “oval” defect (Fig.1). This defect is shaped in the manner of the emitted light, and is aligned with the active epitaxial region. FIB cross sectioning was chosen in order to gradually expose the interface of the facet coating and semiconductor laser bar at the defect region. The resulting FIB trench showed that not one, but two areas of material alteration existed. First, the oval defect, which was discovered originally with the SEM, was shown by FIB to definitively be within the facet coating. Small voids were found beneath the surface of the oval defect. A second feature, named the “comet tail” defect (Fig. 2), was discovered extending backward into the semiconductor laser bar.

“Oval” Facet Coating Defect. There are two possible points of origin for the degradation process that produced the oval facet coating defect: 1) a condition of non-ideal composition within the deposited coating layer, or, 2) at the facet coating /laser bar interface. Both of these points of origin would have the end result of altering the physical and chemical protective properties of the facet coating.

“Comet Tail” Defect. The “comet tail” feature is altered semiconductor laser bar material. It exists within the active epitaxial region. Oxidized semiconductor material will show up lighter in atomic number contrast in the SEM [1]. Laser bar facet oxidation is the breakdown of the original epitaxial compounds of the semiconductor. EDS elemental analysis performed on the defect, both un-sectioned and FIB-sectioned, show a depletion of arsenic (Fig 5a,c). Arsenic oxidizes most easily of all the elements present in a semiconductor crystal design, and is also the most mobile [1] [2].

Chronological Relationship of the defects. The heat from the laser light caused a localized physical-chemical change within a specific area of non-ideal facet coating. The simultaneous composition and volume change caused both the oval shape and the small voids present below the surface. As the coating was altered, oxygen, heat, and light to the semiconductor laser bar increased,

causing both oxidation and non-radiative recombination to propagate. This active process caused the chemical changes that advanced into the laser bar crystal, and is evidenced by both the comet tail defect and the depletion of arsenic concentration. Light absorption at the facet, electron-hole pair generation, non-radiative recombination, heating, and facet oxidation all play a role, as the dynamic material mechanisms of the Oxidation Feedback Loop and COD [1]. Shown here are the very beginning stages of this loop.

Fig. 1 SEM: Oval Defect on laser bar front facet. **Fig. 2** FIB: Trench shows Comet Tail Defect. **Fig. 3** Oxidation Feedback Loop: M. Fukudo [1]. **Fig. 4** Optical Microscope image of laser device. **Fig. 5** As depletion: **5a.** EDS: oval defect, **5b.** EDS: area w/out defect, **5c.** EDS: front facet w/defect.
