Failure Analysis of Crimp Connectors

P.T. Vianco, A.C. Kilgo, R. Grant

Sandia National Laboratories, Albuquerque, NM 87185

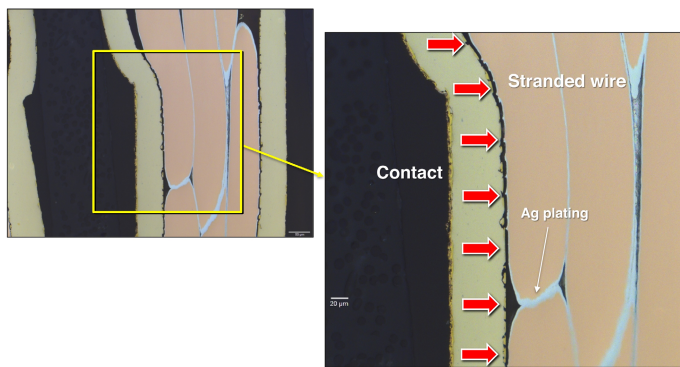
The high magnification images in Fig. 1 show one of the crimp joints. The red arrows in Fig. 1a indicate a gap between the wire strands and the contact surfaces. The optical micrograph in Fig. 1b shows a periodicity of two fracture morphologies. One morphology was separation between the Au plating and the Ag plating on the contact and stranded wire, respectively (green arrow). The second morphology was separation between the Ag finish of the wire and bare Be-Cu of the contact (orange arrow). In the case of the first failure site, it is recognized that Au and Ag surfaces are susceptible to contamination from exposure to the air environment. Such contamination, whether on one or both surfaces, can interfere with the formation of the cold-weld bond.

Fig. 1 (a) Optical micrographs shows the absence of a bond (red arrows). (b) The green and orange arrows indicate Au/Ag interface failure and bare Be-Cu/Ag interface failure, respectively.

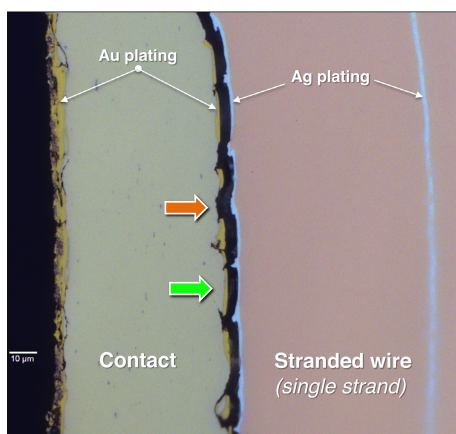
(b)

In the second case (orange arrow), the damage originated from the forming process used to make the crimp structure. There was Au as well as Ni plating layers *within* those near-surface cracks that confirmed that the damage occurred prior to the electroplating process as shown in Fig. 2. The pressure of the crimping process loosened or fragmented the damaged segments. Then, upon the elastic rebound, those fragments separated from the contact surface and were lost during the metallographic cross section preparation process.

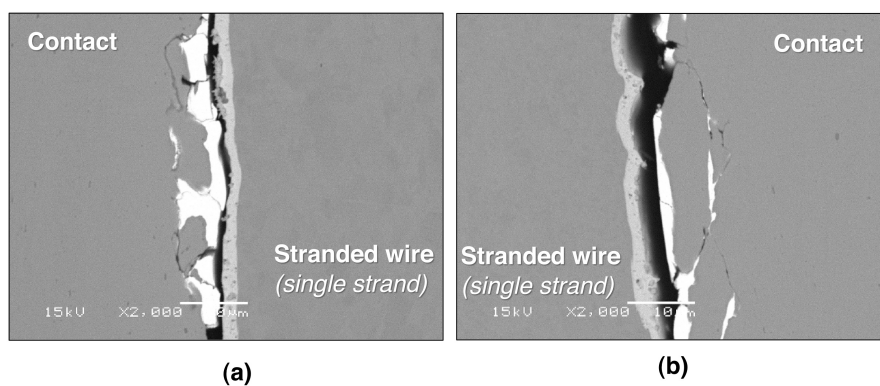
Fig. 2 SEM photographs show the damage to the contact material surface and sub-surface regions as indicated by the electroplating of Au within the cracks and gaps.
