Titanium (Ti) Alloy Electron Beam (EB) Weld Fracture Surface Interpretation

Steven J. Gentz¹

¹ NASA, Langley Research Center, Hampton, VA

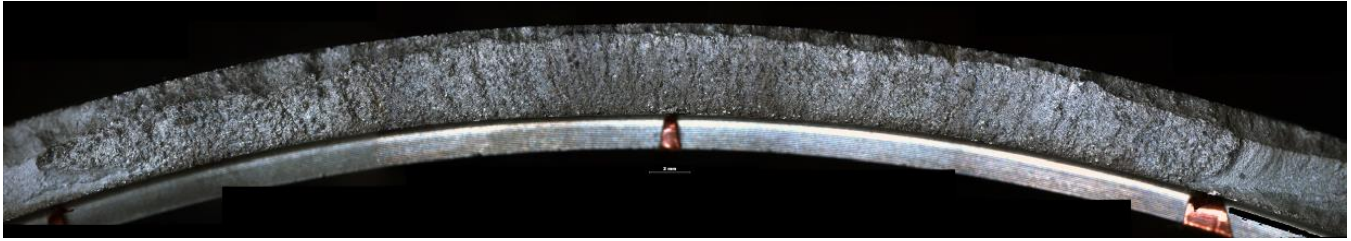
The fracture surface presented three distinct zones, which were labeled the initial fracture (Figure 1), fast fracture, and final overload. The initial fracture was approximately 6.5 cm long and centered at the EB cover pass overlap. When viewed with a stereomicroscope, this zone was distinctly different from the adjacent fast fracture region, had an OD shear lip, and numerous tear ridges converging at multiple inner diameter (ID) locations. In addition, a demarcation line was seen at approximately mid span through the thickness. Depending on the light source and viewing angle, this boundary line appeared to turn towards the ID surface. As the vessel was subjected to repeated pressure cycles, this region was suspected to be a fatigue crack approximately 6.5 cm long by 0.3 cm deep. The project manager and structural analyst received this preliminary observation with alarm and skepticism as a defect of this magnitude should have failed well before the recorded burst pressure.

Figure 1. Initial Fracture Zone in Circumferential EB Weld Showing OD Shear Lip, Tear Ridges, and Mid Span Demarcation Line (3x magnification)

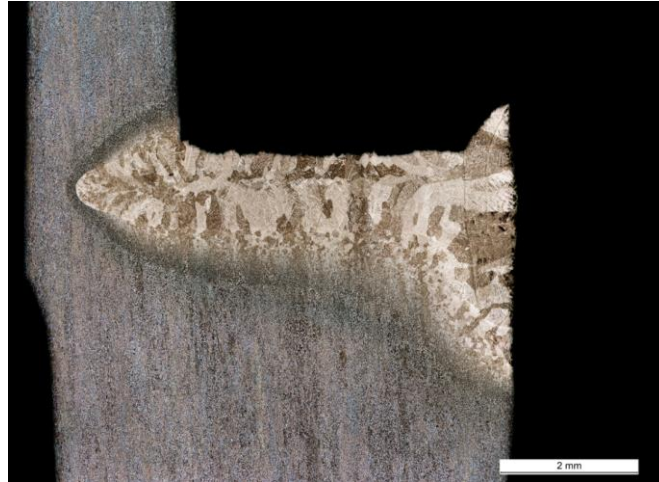
Subsequently the fracture surface was examined with electron microscopy and sectioned for metallography. Microscopy determined the preponderance of crack extension in this zone was a combination of ductile dimple and cleavage fracture with no evidence of organized cyclic fatigue. Metallography (Figure 2) determined the reported OD shear lip was associated with the EB cover pass fusion zone, and the demarcation line was a microstructural thermal effect from the cover pass. Figure 3 shows a composite of the metallography section compared with the corresponding location on the matting fracture surface.

Figure 2. EB Weld Fracture Cross Section (10x magnification, etchant – Kroll's reagent)

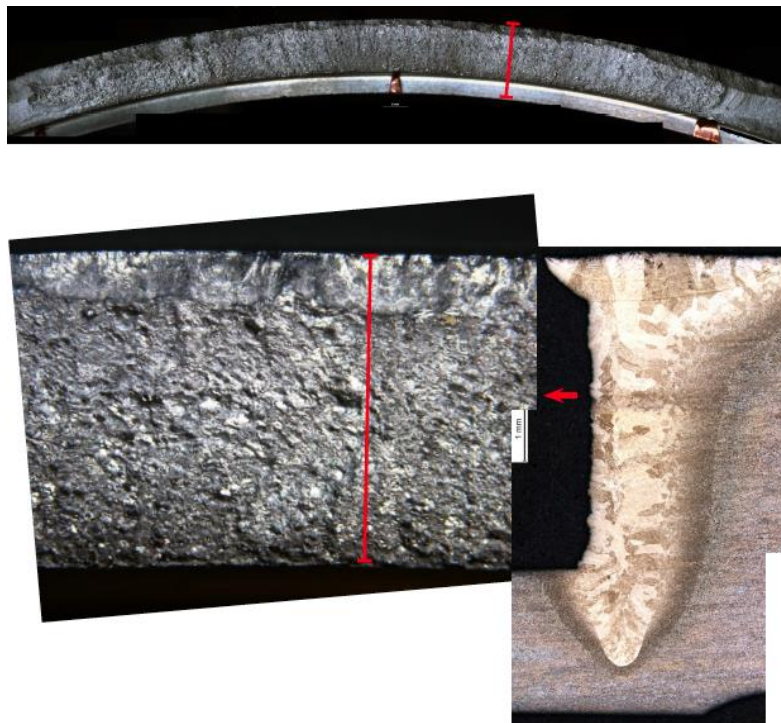
Figure 3. Composite of Optical, Electron Microscopy, and Metallographic Images Showing Relationship of Demarcation Line to Microstructural Feature (line indicates sectioning location)
