Multi-scale Investigation of the Hydrogen-Assisted Failure of X65 Pipeline Steel

M. Martin^{*}, I. Robertson^{*}, B. Somerday^{**}, C. San Marchi^{**}, and P. Sofronis^{***}

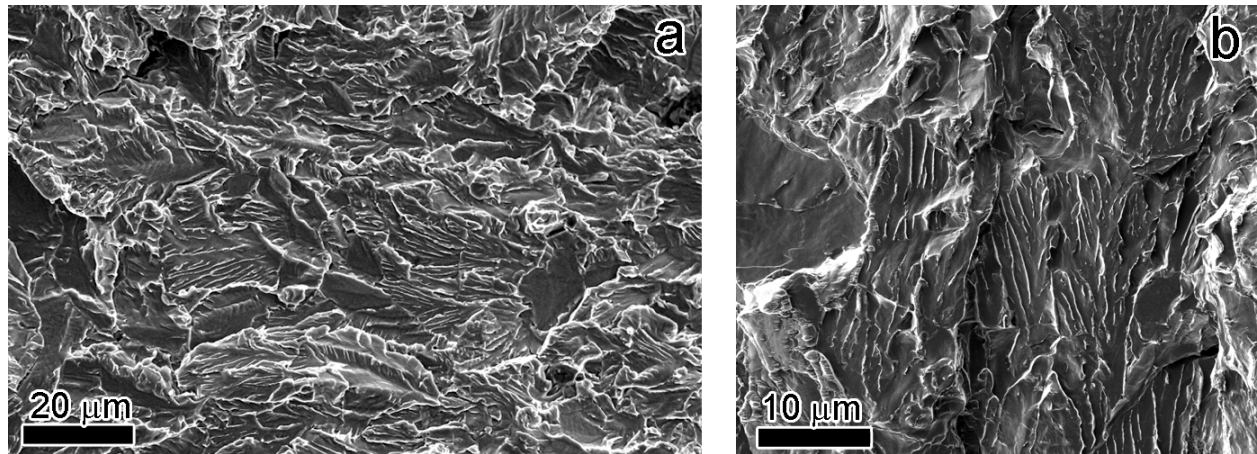
Compact tension specimens of API Grade X65 HIC pipeline steel were tested at Sandia National Laboratory (Livermore) in 20 MPa hydrogen gas. An example of the resultant fracture surface is shown in Figure 1a. Some regions exhibit facet-like features and others are flat with features that resemble river patterns – the latter fracture surface, shown at higher magnification in Figure 1b, is commonly characterized as quasi-cleavage [3]. Such surfaces are not unique to this system as similar features have been observed on fracture surfaces of X70/X80 pipeline steels tested under this condition. To understand the formation of the quasi-cleavage surfaces, focused ion beam machining was used to extract samples from specific locations to enable determination of the microstructure immediately beneath the fracture surface. In this way, a correlation between fracture surface and microstructural features, such as secondary phases, dislocation structures, sub-grain boundaries can be made. In addition, the same area of sample was viewed over a wide angular range with images captured every few degrees of tilt and these were used to create a topographical map.

FIG 1a. SEM wide view showing features on fracture surface. **b.** Higher magnification SEM of feature of interest.

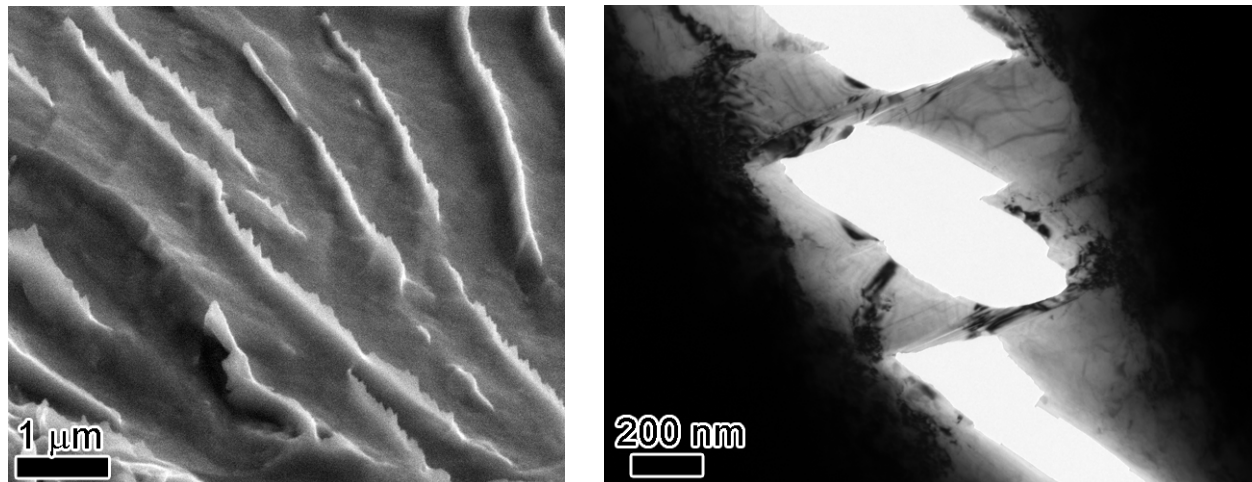
The series of images in the tilt sequence and the surface topography map reveal the ridges on the quasi-cleavage fracture surface protrude from the surface and show that saw-tooth like features decorate the ridge peaks. These features are evident in the fractograph presented in Figure 2. They appear thin and are reminiscent of saw-tooth features produced during the final stages of separation in an electron transparent section bounded by electron opaque regions, Figure 3. In the latter case, the saw-teeth edges parallel slip or twinning planes and are attributed to the crack propagating along the slip band or the twin plane. This interpretation of the features on fracture surface suggests they are formed as a consequence of the elongation and growth of parallel channels with the ridges forming the walls between the channels. The nature of these channels

FIG 2. Fractograph showing the ridges with the saw-teeth on the ridge peaks.
