## Novel Insights into In-Service Oxidized Inconel 625 Engine Exhausts by a Multi-Technique Approach

P.A.J. Bagot<sup>1</sup>, P.D. Edmondson<sup>1</sup>, G.M. Hughes<sup>1</sup>, A. Crossley<sup>1</sup> and D. De Lille<sup>2</sup>

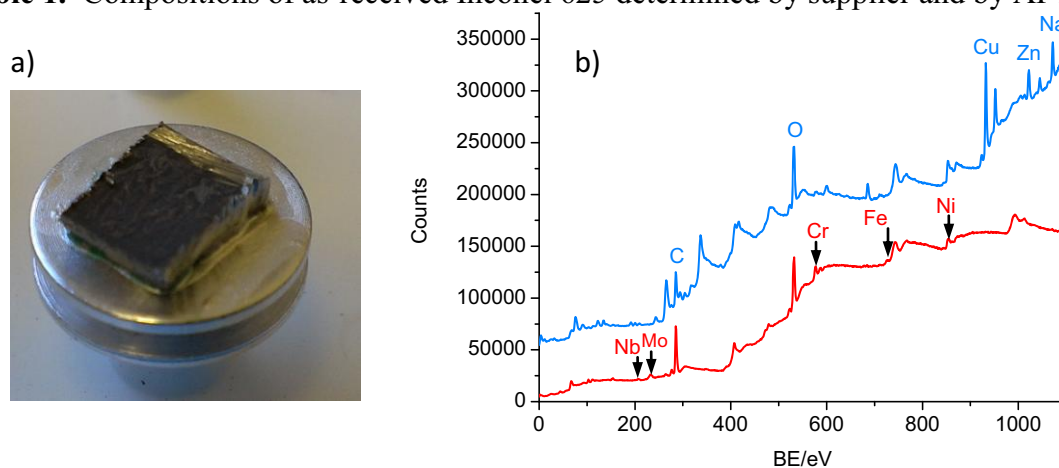
We firstly analyzed a stock sample of as-received (heat treated at 1040°C) Inconel 625. Table 1 shows the numerical data from the alloy manufacturer (Special Metals) using X-ray Fluorescence and from an electropolished sample analyzed by APT. The agreement between compositions is very good. XPS was also used to examine the as-received material, before turning to the surface and near-surface chemistry of the oxidized sample shown mounted in Fig. 1a). The composition of the outer surface is mainly C and O, however using ion-bombarding to dig below any surface contamination (a few tens of nanometers), C (40 at.%) and O (34 at.%) species are again detected along with unexpected Cu (7 at.%), Zn (2 at.%) and Na (6 at.%), Fig. 2b). This suggests upstream contamination, possibly from fuel additives/lubricants.

**Figure 1.** a) Extracted sample from oxidized Inconel 625, b) XPS spectra from near-surface (blue) of sample shown in a), and of as-received alloy (red), selected elements shown.

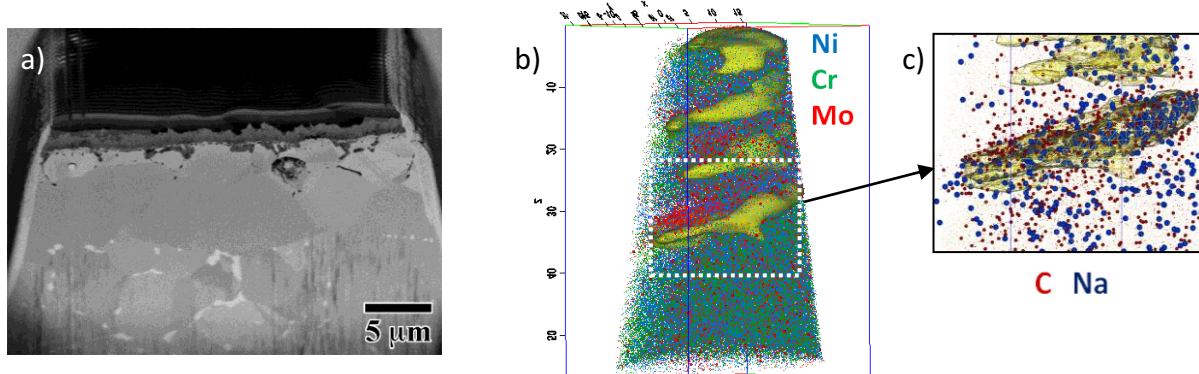
FIB sectioning reveals further oxidation-induced features, Fig. 2a). At the top surface, we see a corrugated but complete oxide layer, ~1–2 μm thick. Below this a number of small dark precipitates are concentrated along grain boundaries to a depth of ~5 μm. At this same depth we also observe a number of large voids, 3 μm in diameter with the centers located at grain boundary intersections. The prevalence of these may have played a role in the component failure. Deeper down a zone of ~10 μm is precipitate-free, followed by a final layer of larger precipitates again concentrated along grain boundaries. The chemistry of the oxide/precipitates is currently under investigation, but based on a comparable SEM/EDX study on furnace oxidized Inconel [1] the oxide is likely Cr<sub>2</sub>O<sub>3</sub>, the dark precipitates Al<sub>2</sub>O<sub>3</sub> and the deepest precipitates M<sub>6</sub>C carbides (M=Ni, Mo). What is striking however is that in this previous work the alloy was exposed for 1000 hours, but after only 30 hours in this study we see similar features.

Preparing an APT sample from this is challenging, and requires sampling from multiple locations avoiding any voids to explore the full microstructure. Nevertheless we have recently carried out the first FIB-liftout experiment on this type of “in-service” component, extracting a sample  $\sim 1\mu\text{m}$  below the surface. The resulting atom maps are shown in Figure 2b) and c). In b) the major constituents of the alloy are shown, along with an oxygen iso-concentration surface clearly shows the formation of oxide bands spaced approximately 10nm apart. In c) minor species of C and also Na as identified in the XPS are shown accumulating at the lower iso-surface, while Cu and Zn (not shown) were also confirmed throughout the volume.

**Figure 2.** a) SEM image of oxidized Inconel 625 during FIB slicing, revealing oxide cap, G.B. precipitates, precipitate-free zone and void at G.B. intersection. b) APT reconstruction from oxidized alloy, extracted  $\sim 1\mu\text{m}$  from surface showing main species and oxide band (oxygen iso-surfaces set at  $21\text{atoms}/\text{nm}^3$ ). c) Magnification of lower oxygen iso-surface, showing C and Na segregation to oxide.
