Unusual Failure of a Rim Fire Cartridge Brass Casing

F.E. Schmidt, Jr., * and J.L. McDougall **

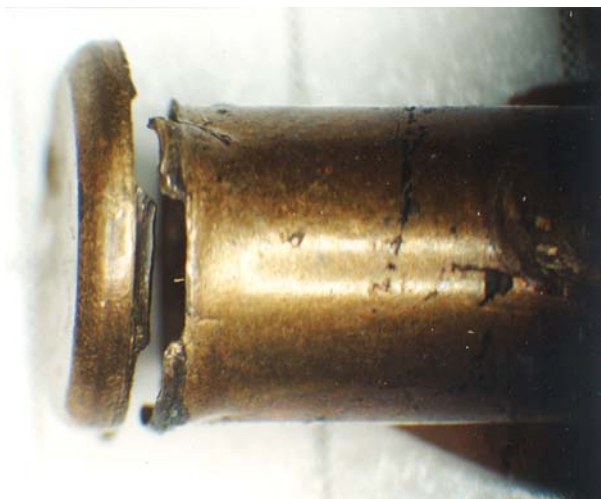
FIGURE 1

FIG. 1. Stereo Optical Micrograph of a side profile view of the RF casing (~10 X).

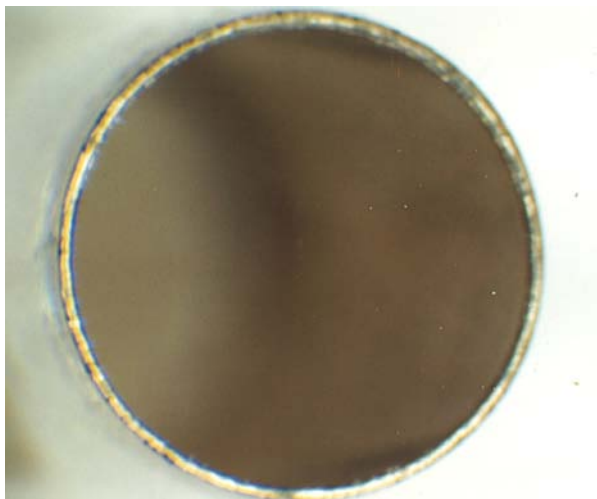
FIGURE 2

FIG. 2. Stereo Optical Micrograph of mouth of casing, indicates proper bullet insertion (~15 X).

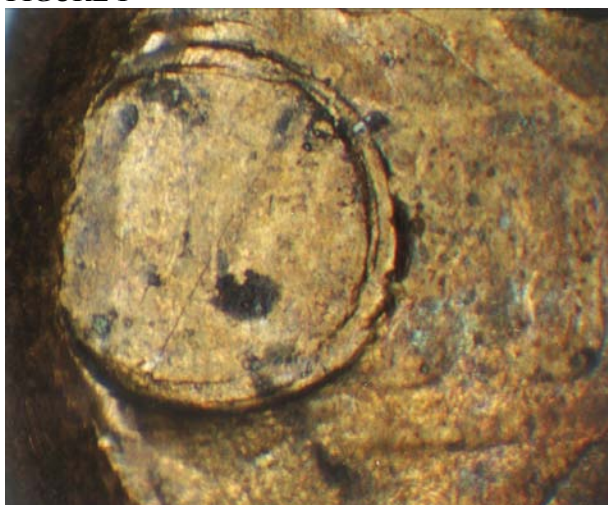
FIGURE 3

FIG. 3. Micrograph of Case Head where Brass is extruded into the Firing Pin Slot (~ 40 X).

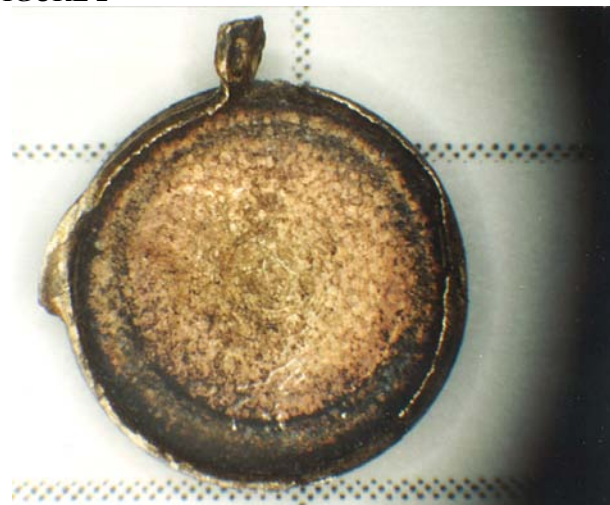
FIGURE 4

FIG. 4. Micrograph of inside Case Head, indicates uniform deformation and tearing (~ 10X).

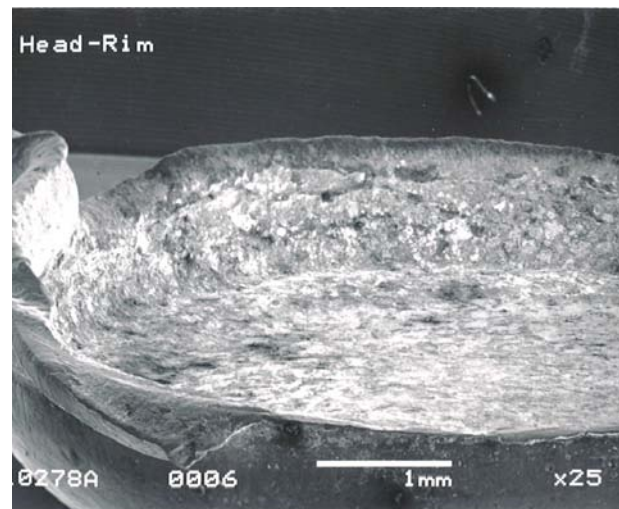
FIGURE 5

FIG. 5 SEM Micrograph of inside region of Case Head, ductile – rupture (shear mode) (~ 25X).
