## Failure Analysis in Support of Deformation Modeling

Lisa Deibler<sup>1</sup>, Edmundo Corona<sup>1</sup>, Shelley Williams<sup>1</sup>

<sup>1</sup> Sandia National Laboratories, Albuquerque, NM

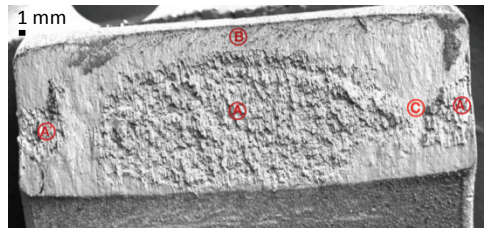
Figure 1: Sample geometry

The sample for the 2013 Sandia Fracture Challenge was made from A286 steel in the geometry pictured in Figure 1. The sample was compressed during testing, causing shear along the two ligaments marked A and B in Figure 1. A group at Sandia modeling the part found that their prediction of the force-displacement curve began to deviate from experimental results before the sample reached its maximum load. Fractography and metallography were employed to better understand if there were microstructural processes that the model was not capturing which could lead to the deviation from experimental data.

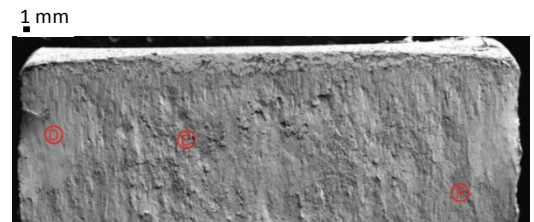
Figure 2: Right side fractured ligament

Examination of the fracture surfaces of the two ligaments, A and B, showed that they were different as seen in Figures 2 and 3, indicating some asymmetry in the sample at least during final failure. The general morphologies of the fracture surface areas were similar, but the micro-scale fracture features were different. This presentation will focus on the results from the right sides of the samples. The region marked A showed a very rough surface with equiaxed dimples, indicating a tensile failure mode. Region B contained vertical smears, as though the surfaces had rubbed together after initial separation. Region C was flat with small, elongated dimples, indicative of shear failure. The fracture surface evidence indicates that failure likely began at areas B and C in shear, and then areas marked A failed last.

The images of samples 1 and 2 indicate that damage which would not have been captured by the model does not begin to accumulate until the maximum load. The images of sample 3, unloaded just before failure, indicate that extensive cracking does indeed occur at the top and bottom surfaces and at a quarter of the way through the sample (areas B and C in Figure 2).
