## Analysis of a Spiral/Spliced Pipe Weld Hydrostatic Test Rupture

J. L. McDougall \*, F. E. Schmidt, Jr. \*\* and M. E. Stevenson \*

\* Engineering Systems Inc., 6109 Regency Parkway, Suite 316, Norcross, GA 30071

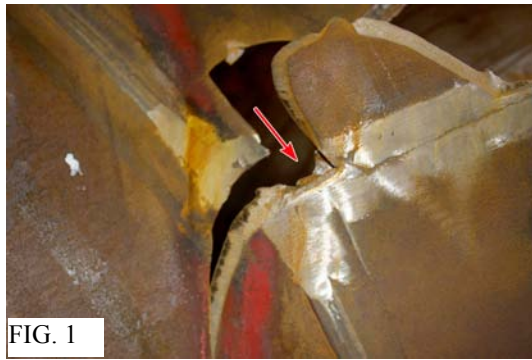
In conclusion, the presence of porosity, both macro wormhole and micro shrinkage associated with the fracture, initiated the rupture. However the presence of moisture as a consequence of no preheating may also have been a contributing factor to the entrapped gas generation. The presence of localized discoloration associated with the fracture origin also suggests incomplete weld penetration; evidence of modest weld penetration was observed adjacent to the fracture origin. Although strong evidence of HAZ cracking was not observed, the client was advised to pay closer attention to the carbon equivalent values when making the determination to utilize preheating and/or post-weld heat treatment.

FIG. 1. Macro evaluation of the pipe rupture in splice weld, arrow denotes porosity

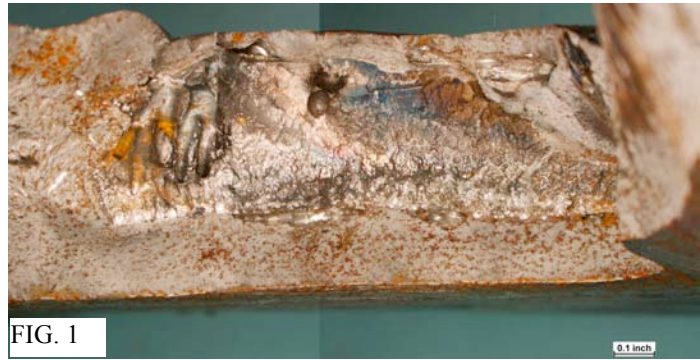
FIG. 2. Composite stereomicroscope of the fracture origin

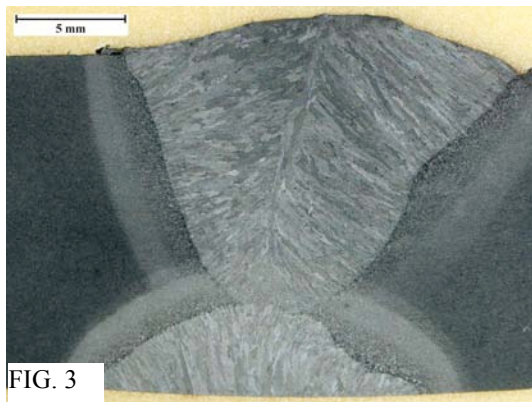
FIG. 3. Macro etch of splice weld with modest penetration (Nital 3%)

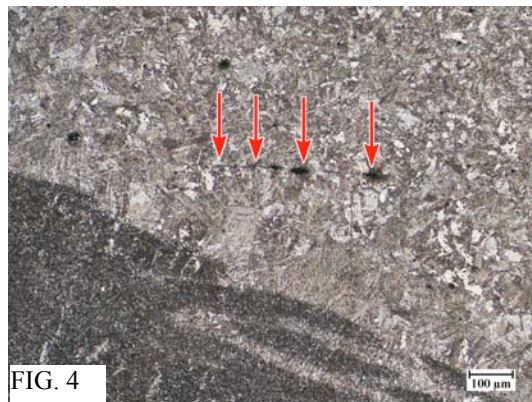
Mechanical property and chemical composition requirements were fully met for both heats of steel. However, the carbon equivalent was sufficiently above 0.40 to be suspicious of post weld cracking. The actual calculated carbon equivalent values were 0.43 and 0.45 for the two heats. Possible evidence of HAZ cracking was observed associated with the inner diameter weld of the splice.

FIG. 4. Evidence of possible HAZ cracking (Nital 3%)

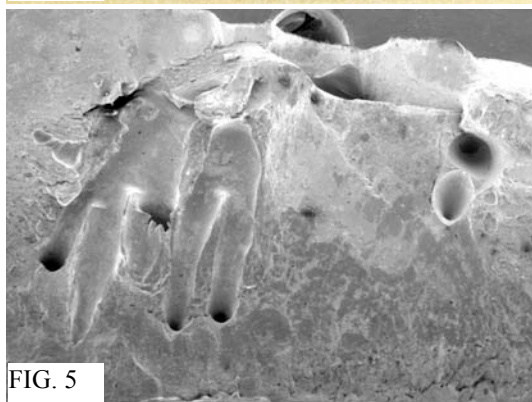
FIG. 5. SEM micrograph of macro porosity

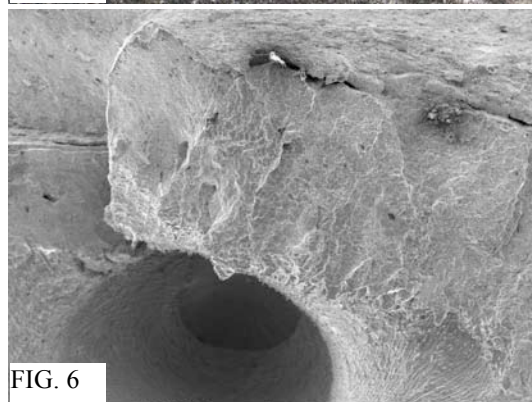
FIG. 6. SEM micrograph of macro porosity and shrinkage porosity

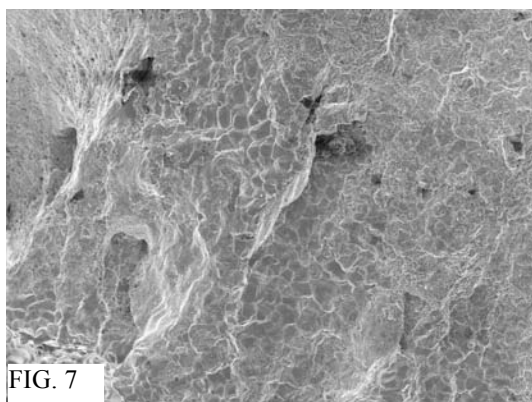
FIG. 7. SEM micrograph of shrinkage porosity

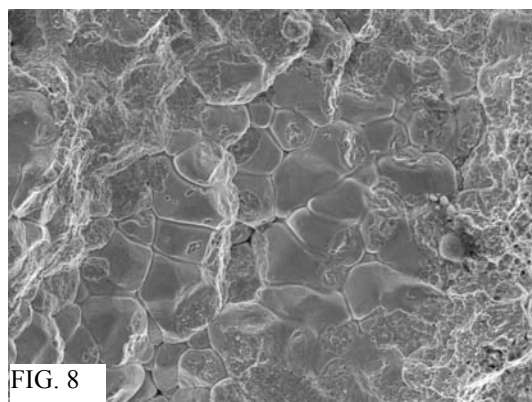
FIG. 8. SEM micrograph of shrinkage porosity
