Mineshaft Roller Bearing Failure Analysis

Ronald J. Parrington,* and David M. Christie*

* IMR Test Labs, 131 Woodsedge Drive, Lansing, NY 14882

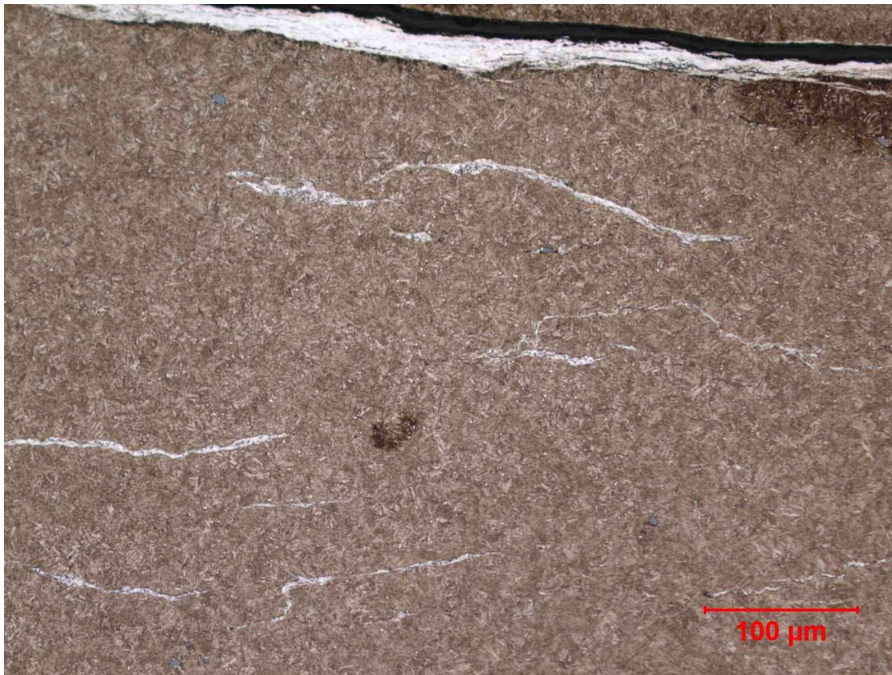
The subsurface origin pitting damage was limited to a region 30 cm in length and was roughly centered in the width of the race. Subsurface origin rolling contact fatigue cracks initiated at unusual depths (up to 1 mm from the raceway surface) and were accompanied by microstructural alterations (i.e., untempered martensite or stress butterflies) as shown in Fig. 1. Subsurface origin pitting normally occurs at a depth of just a fraction of a millimeter. In this case, the subsurface origin pitting is deeper than usual due to the large scale of the bearing components [1].

FIG. 1. Microstructural alterations (i.e., untempered martensite or stress butterflies), indicative of high Hertzian stresses, are associated with the region of subsurface origin rolling contact fatigue.

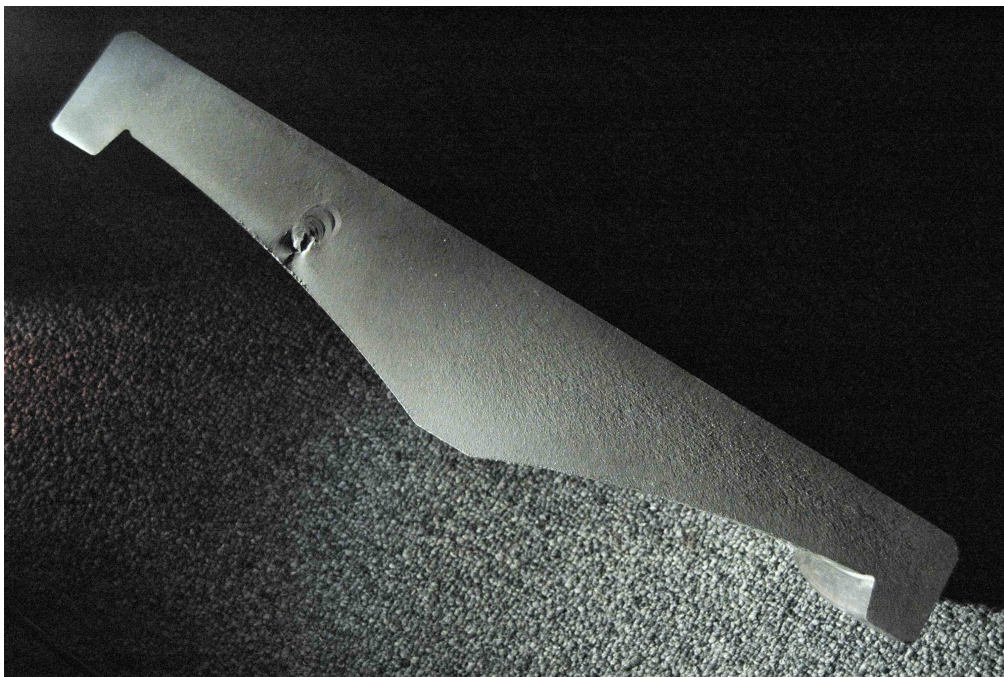
Typical of subsurface origin rolling contact fatigue, branch cracks formed between the subsurface cracks and the surface of the raceway. However, one of the branch cracks running parallel with the raceway turned away from the race surface and towards the inner ring ID. It then propagated by a series of small overload crack extensions (i.e., low cycle fatigue) to a maximum depth of 3.4 cm and culminated in overload fracture of the inner ring. The fracture surface is shown in Fig 2.

Interestingly, thin bands of intergranular fracture were associated with the low cycle fatigue region and were visible as beach marks on the fracture surface. The intergranular fracture morphology was reproduced in the laboratory by notching two opposing sides of a small piece of the inner ring, and then squeezing one notch shut in a vice, placing the other notch in tension. A small region of intergranular fracture was noted near the fracture “hinge” close to the compressed notch. The balance of the fracture was ductile. In contrast, laboratory fracture of three pieces of stock AISI E 52100 bearing steel (very similar composition to the subject bearing) hardened to 59 HRC failed to result in intergranular fracture. Although the material chemistry, microstructure, and hardness are consistent with good bearing manufacturing practices, these observations suggest that heat treatment embrittlement may have contributed to the mineshaft bearing failure.

FIG. 2. Fracture surface of the bearing inner ring
