A Simple Method to Decouple Redeposition-Related Artifacts from Real Defects in the Failure Analysis of Silicon Photonics Modules

Fauzia Khatkhatay^{1*} and Pradip Sairam Pichumani¹

¹ GLOBALFOUNDRIES, Inc., Malta, NY, U.S.A.

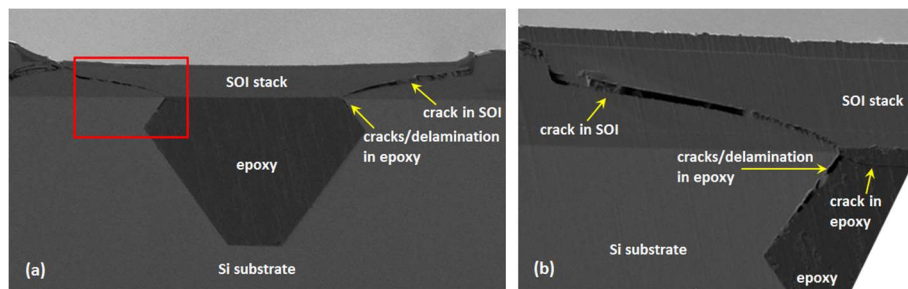
The conventional destructive failure analysis method is mechanical cross-sectioning. The die (or package) is impregnated in epoxy, and then polished by hand. Mechanical cross-sectioning offers the advantage of polishing large areas very quickly. Sometimes, the suspended structures may be filled in with an optical adhesive and cured, in which case the structure is stabilized and less likely to experience external mechanical stress by the epoxy impregnation. However, in the case of free standing structures, it is highly likely that they will crack and get damaged as the epoxy cures. Moreover, mechanical polishing itself is known to generate cracking, pitting, and chipping artifacts, as in Fig. 1.

Figure 1. (a) The mechanically polished sample showing cracks in the SOI and in the epoxy. (b) High magnification image showing the cracks in the epoxy, confirming them to be polish related.

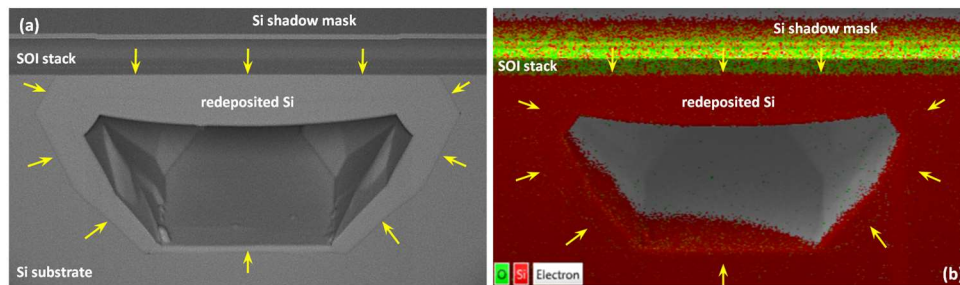
An alternative to cross-sectioning mechanically is to use a focused ion beam (FIB) instead so that mechanically induced artifacts can be eliminated. Fig. 2 shows the FIB cross-sectioned trench. The surface of the chip has been covered by a thinned Si wafer to serve as a shadow mask, to reduce FIB-induced curtaining damage [3]. While no cracks are observed, it is clear that the profile of the cavity has been altered. There is a clear outline of the original trench within which additional material has been filled in, confirmed to be redeposited Si from energy dispersive x-ray spectroscopy (EDS) analysis.

Figure 2. (a) FIB cross-section image for the trench. Yellow arrows indicate the original trench edge (dark outline), the material inside is redeposited. (b) EDS map confirming that the redeposition is Si.

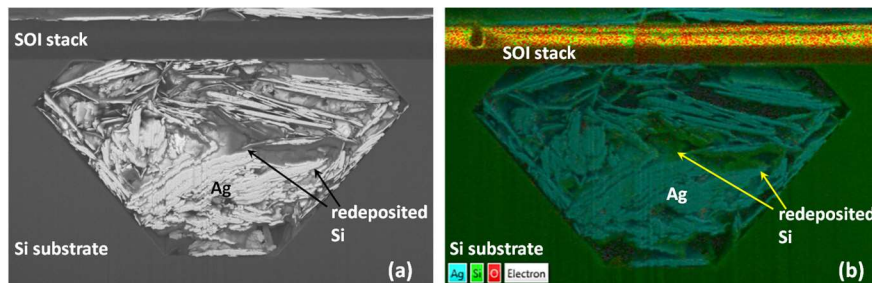
3 are the FIB cross-section images of the Ag paint filled cavity. While the trench is non-uniformly filled, the edge of cavity can clearly be discerned due to the Ag lining. While some of the Ag gaps in the trench do have redeposited Si, it can very easily be decoupled from the original trench profile. This is a quick and simple yet very effective method for profile analysis. Future work includes sputter coating the metal into the cavity for a more uniform deposition [4].

Figure 3. (a) SEM image of the Ag-filled trench, showing redeposition is reduced. (b) EDS analysis confirming the material inside the cavity is the added Ag.

To decouple the redeposition artifacts from the original cavity, it was thought to line the cavity with an additional material that was not originally part of the fabrication process. The entire chip was coated with commercially purchased Ag paint to line the cavity and potentially fill in the trench. Shown in Fig.
