3D EBSD Analysis of Hydrogen Induced Cracking in Pipeline Steel Using Serial Section Broad Ion Beam Tomography

M. K. O'Brien¹, K. O. Findley¹, T. Hosman² and J. A. Hunt².

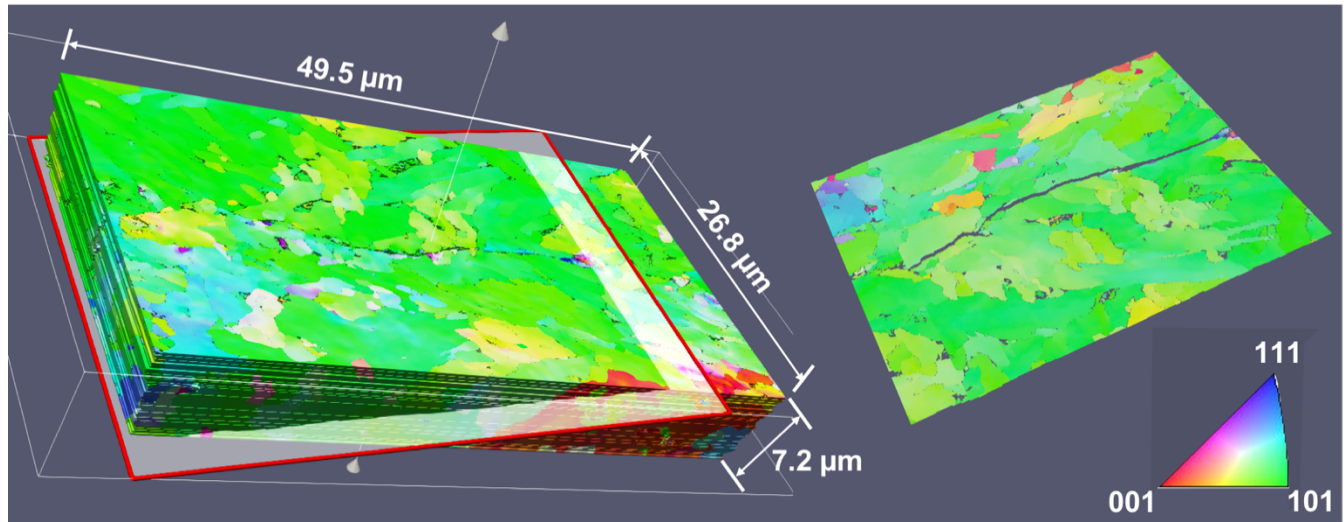
Figure 1. 3D EBSD reconstruction of region near crack tip of hydrogen induced cracking in the X70 steel alloy sectioned using Gatan iPrep SSBIB and colored using IPF coloring.

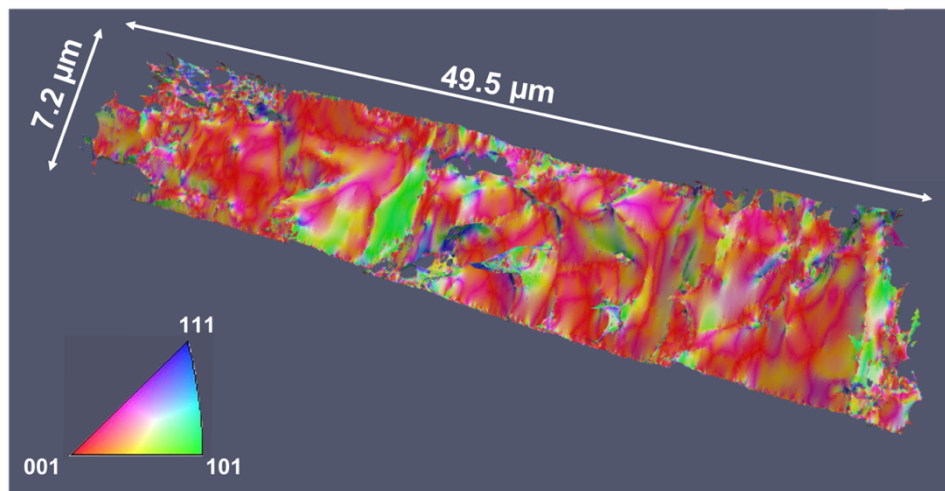
This tomographic reconstruction technique was utilized to characterize HIC damage. The X70 alloy was first charged with hydrogen using NACE Standard TM0284 and sectioned mechanically to locate cracks [3]. The cracked faces were then sectioned using SSBIB, and EBSD and EDS data were collected for each section. 3D reconstructions were then created using DREAM.3D [4] software and imaged using Paraview, an example of which is shown in Figure 1. The crack was then isolated from the 3D reconstruction with plane normals colored according to the inverse pole figure (IPF) coloring scheme, shown in Figure 2. This information is being used to assess the crystallographic planes where cracking occurs both in transgranular and intergranular regions. Initial results indicate that cracking does not occur preferentially on BCC {110} slip planes, but rather might prefer planes ranging from {001} to {112} in the IPF color scheme.

Figure 2. 3D reconstruction of the hydrogen induced crack observed in Figure 1 obtained using Gatan iPrep SSBIB, reconstructed using DREAM.3D, and colored using IPF coloring.
