## **Materials Evaluation and Monitoring of a Large-Scale Conservation Project: Eight Monumental Bronze Sculptures by A.M. Calder**

Andrew Lins

Conservation Department, Philadelphia Museum of Art, PO Box 7646, Philadelphia PA 19101

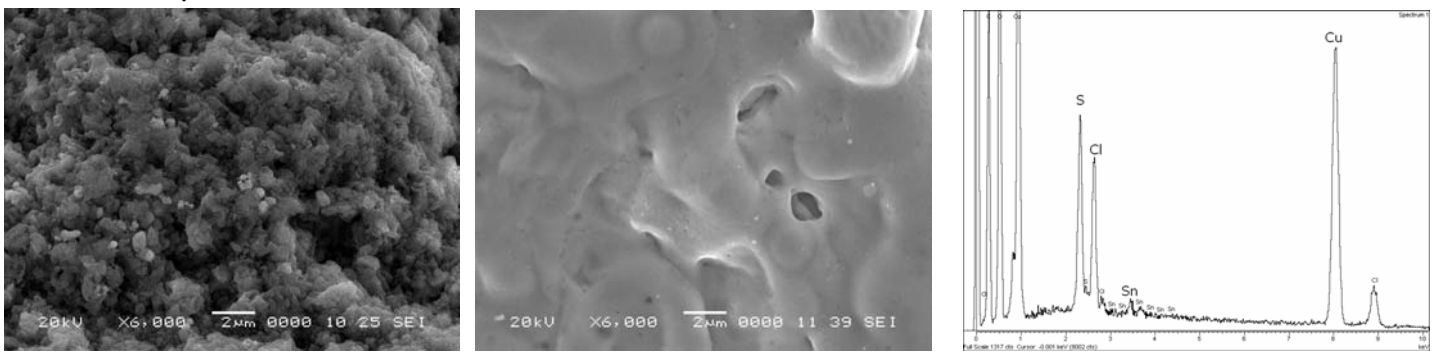
Coincident with the massive, though short-lived energy absorption that created the gas by-products, there was a selective loss of low melting point components of the various bronze alloys of the castings, in particular the tin-rich delta phase, the separate lead phase, and zinc from the alpha phase. In effect, the laser interaction appeared to have created a copper-enriched surface with fewer elemental inhomogeneities than were present in the original alloy, producing more uniform and more reliable substrates on which to build a stable mineral layer of patination and protective coating. Also observed during these analyses was the “shadowing” of the beam when it encountered non-vertical porosities or flaws in the surface; i.e., the beam could not ablate corrosion from surface pits if those pits ran at an angle to the surface, instead of straight down from the surface. All aspects of the finish procedures (steaming/rinsing, patination, inhibitor application, and coating) also were evaluated and monitored during the project, providing direct, real-time feedback with the goal of substantially improving quality control and the performance/longevity of the treatment. A positive byproduct of the project has been research on a fluorocarbon coating to extend the lifetime of the restoration, with potential benefit to the conservation field.

Image at 6000X of weathered surface. Image at 6000X after laser cleaning. Representative EDS spectrum of a scraped surface reaction product after cleaning.

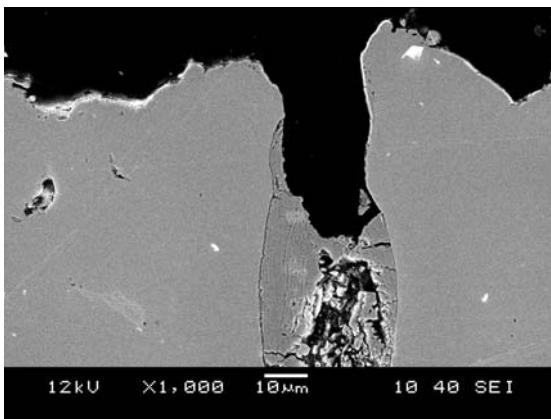
As work progressed on site in 2005, the susceptibility of newly lasered surfaces to re-corrode also was followed in a series of tests over the course of a month. These tests indicated that many black areas harbored antlerite and chloride-rich species that became active corrosion sites after lasering. This finding resulted in a more controlled laser dwell time on those black areas and improved rinsing and patination procedures to eliminate chlorides, the principal cause of premature coating failure in similar projects. Of concern during this analytical work was the occasional

1000X SEM image of deep surface pit after laser cleaning. The laser cleaned the upper 40  $\mu\text{m}$ ; below corrosion remains

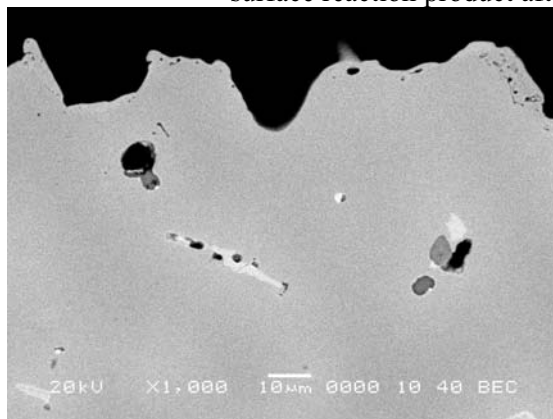
1000X SEM laser cleaned surface. Image shows spherical porosities at the metal/air interface, due to generation of gas during ablation..
