Electron scanning microscopy analysis of fracture surfaces in laser welded samples of hardmetals

R.M. Miranda*, ** and R.J.C. Silva***

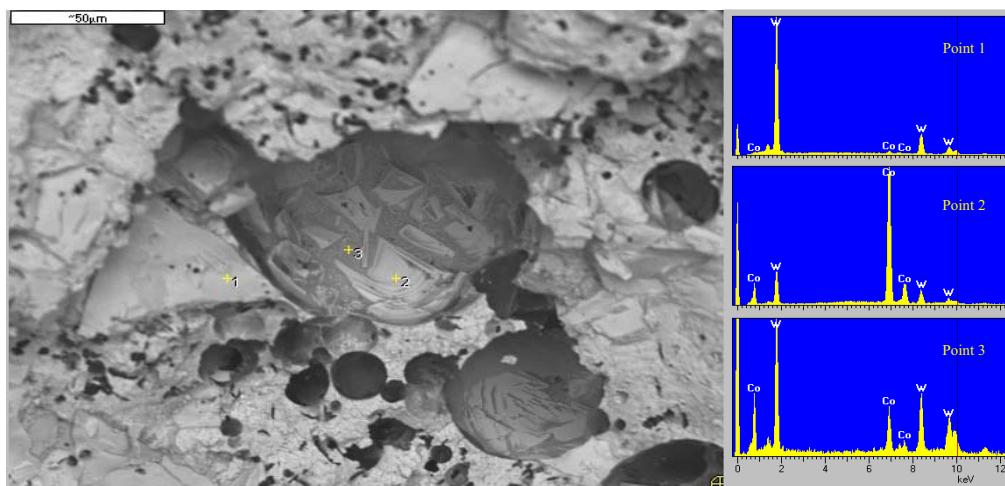
Analysis under scanning electron microscopy showed these pores were coated with a thin film. Observations with energy dispersive spectroscopy (SEM-EDS) revealed this film is rich in cobalt and is highly unstable. Figure 1 shows the characteristics of the film around a pore evidencing its corrugated aspect originated during rapid cooling conditions verified during laser welding.

Fig. 1. SEM backscattering image of a fracture surface in a laser welded sample. Local EDS analysis shows a Co-rich film coating pores walls.

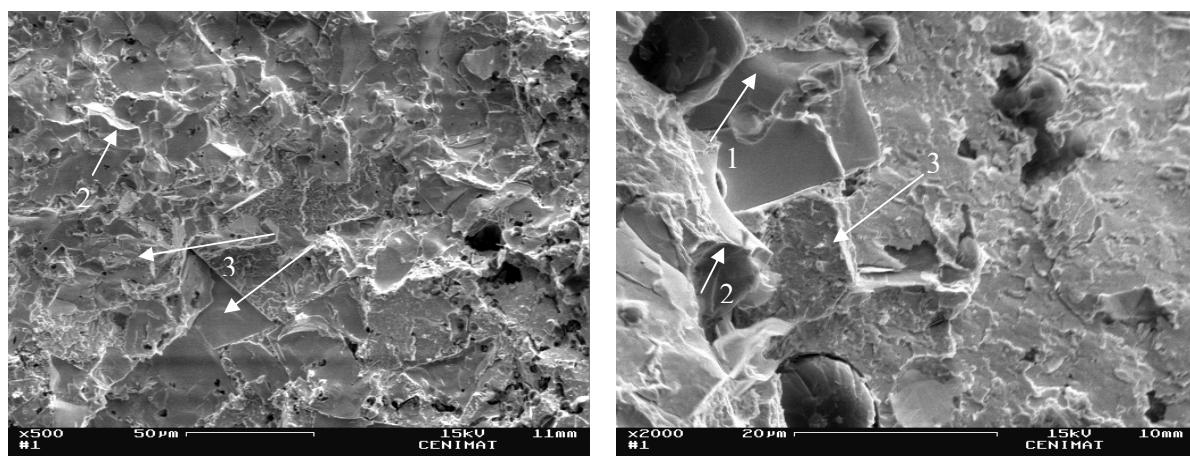
Analysing the fracture surface of GD 50 laser welds under SEM it can be seen that fracture is mostly due to transcrystalline fracture through the carbide crystals identified by a river like marking pattern as shown in Fig. 2.

Fig. 2. Fracture surface observation of GD 50 in SEM with secondary electron beam showing three fracture modes: (1) fracture along carbide phase; (2) intercrystalline carbide; (3) transcrystalline carbide.

Fracture occurs on the fusion zone parallel and transverse to the weld direction in a brittle like mechanism showing transcrystalline cracks and intergranular ones.

Small pores were seen on the surface which are not the major cause for failure since induced residual stresses computed are above the material strength.
