Using Electron Microscopy to Investigate Degradation of Candidate PEM Membranes due to Exposure to Fenton's Reagent

S.C. Weakley-Bollin* and M. Sulek*

*Ford Motor Company, Research and Innovation Center, PO Box 2053, MD 3182, Dearborn MI 48121

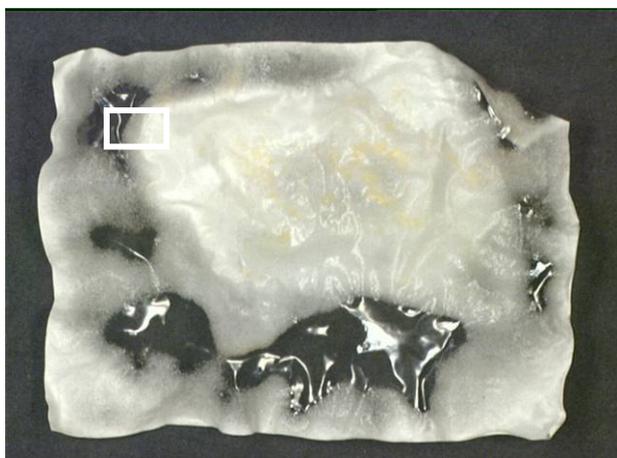
After exposure, some sections of the membranes remain clear, while others become opaque, with either a white or yellow hue (Figure 1). Examination in the SEM showed that the clear areas of the membrane showed very little damage, while the surfaces of the opaque areas of both membranes were covered in bubbles (Figure 2). Some of these bubbles are split either on the top or along the sides. The bubbles are likely due to the formation of CO_2 and HF gases from the reaction of the peroxide with the membrane material which is catalyzed by the Fe^{+2} present in the solution. The affected surfaces of both Membranes A and B appear to be similar, although Membrane B appears to have a wider size distribution and higher density of bubbles compared to Membrane A. Cross-sections of the membranes reveal two very different morphologies (Figure 3). Membrane A has both the larger sized (~30-40 μm) bubbles that are seen on the surface plus a significant amount of smaller porosity (< 1 μm) in the middle of the membrane that is not seen on the surface. This porosity is also found in areas of the membrane before any large bubbles occur. Membrane B does not have any of the numerous smaller pores that were observed in Membrane A, but contains large bubbles and cracks not only on the surface, but through the core of the membrane. Swelling of both membranes is also visible in the cross sections.

Figure 1: Optical image of example membrane after exposure (rectangle indicates an example of an area where a cross-section would be taken)

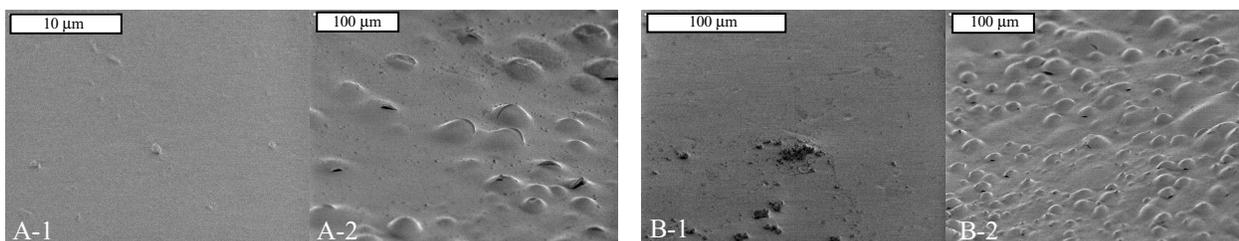
Figure 2: Secondary electron images (SEIs) of the surface of Membranes A and B in unaffected (1) and affected (2) areas ($E_0 = 1 \text{ keV}$)

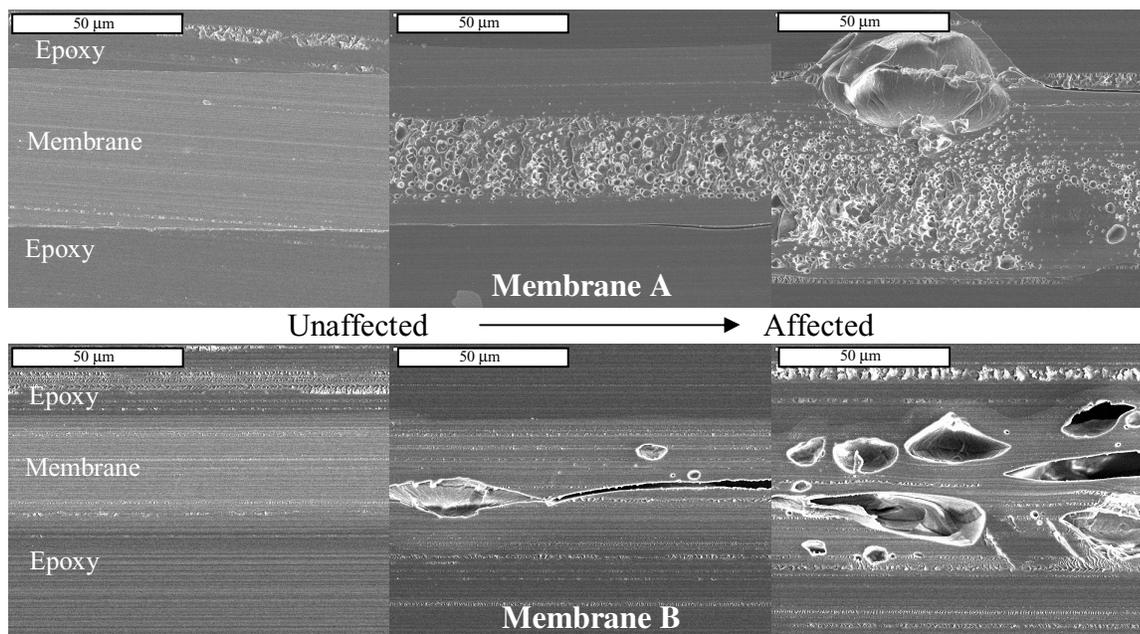
Figure 3: SEIs of cross-sections of Membrane A and B from unaffected to affected areas ($E_0 = 5 \text{ keV}$)
