Microstructural Insights into Pb-Caustic Stress Corrosion Cracking in Alloy 690TT

G.B. Mazzei¹, A. D. Horner², F. Scenini¹ and M.G. Burke³

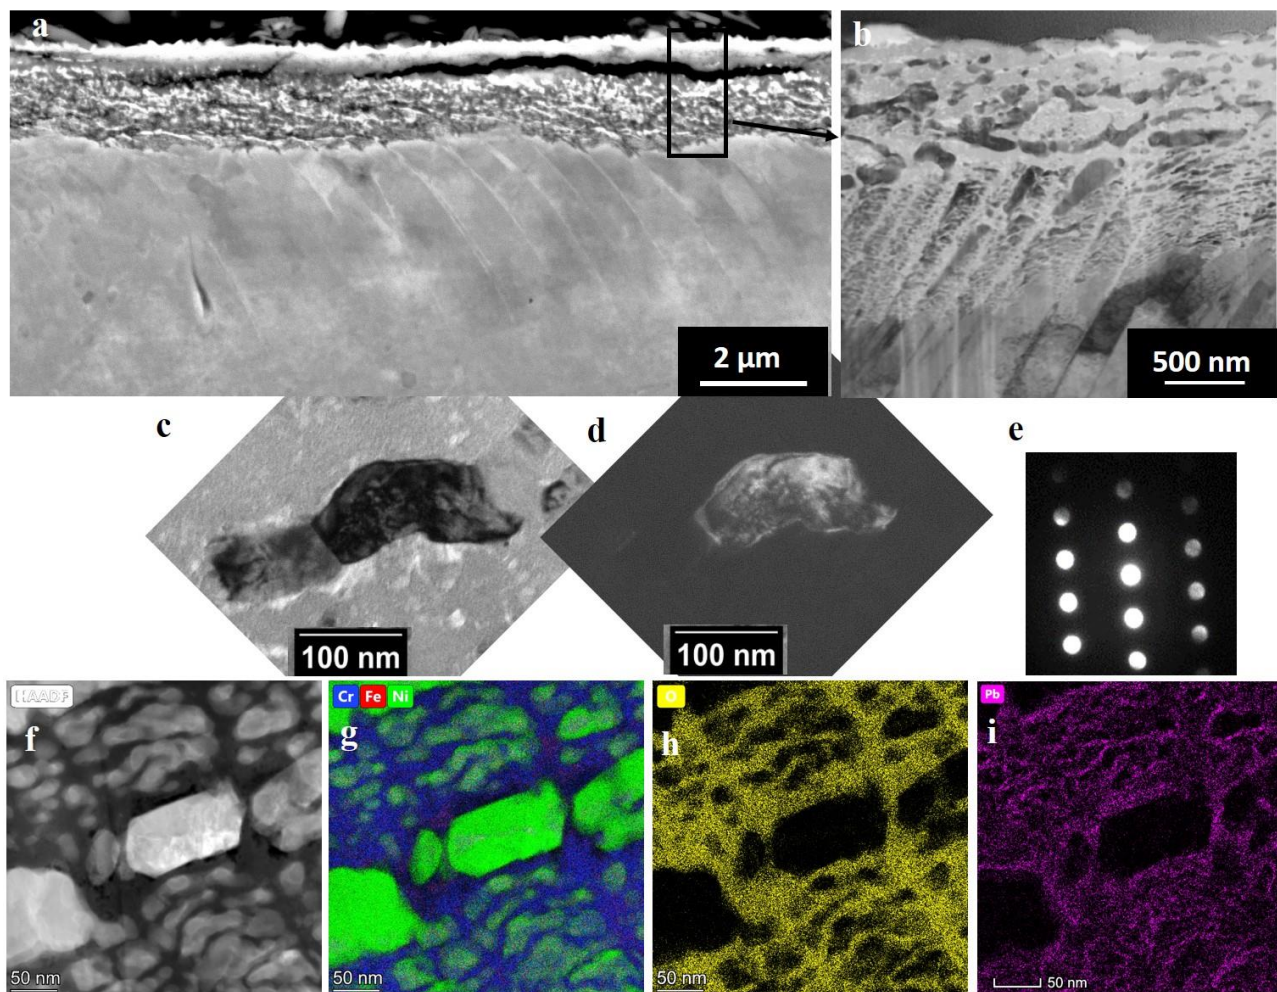
The analysis of FIB cross-section TEM specimens and crack-tip samples further confirmed the presence of metallic Ni as islands (Fig. 1 (c)-(e)) and along the flanks of cracks originated from corrosion slots (Fig. 2 (f)) with more fracture surface cross-section analysis in [2]), indicating that de-alloying occurred under the Pb-caustic conditions. The presence metallic Ni surrounded by oxide can be explained by the oxidation behaviour of Ni, Cr and Fe in this environment: Ni is more noble than Cr and Fe. Thus, metallic Ni would be “left behind” during the oxidation of the deformed zone in the AR specimen.

Figure 1. (a) SE image of cross-sectioned post-test AR sample. (b) HAADF STEM image from the oxidised region; (c) BF and (d) corresponding DF TEM images of a nodule of metallic Ni, with (e) associated [013] CBED pattern. (f) HAADF STEM image, and corresponding STEM-EDX maps for (g) Ni K α (green) - Cr K α (blue) - Fe K α (red), (h) O K α and (i) Pb M α showing Ni metal regions within the oxidised layer.

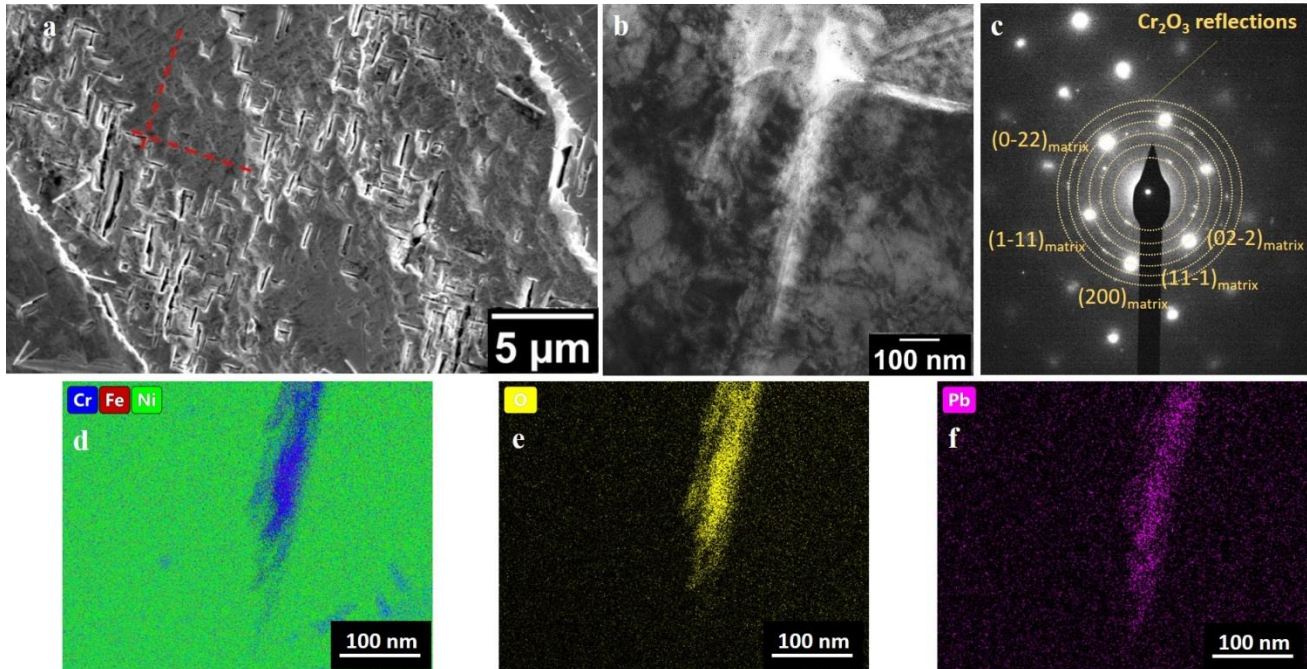
Evaluation of metallographic cross-sections prepared from the tested C-ring samples revealed that the transgranular crack depth was not affected by surface condition (~ 120 μm), although the polished specimen contained ~ 4 times more cracks than the sample with the AR surface finish [2]. In addition, analysis of the post-test samples revealed that the PbSCC environment had different effects on AR and polished surface. The cross-sectioned AR specimen exhibited a near-surface deformed zone characterized by an outer ultrafine-grained layer and a deformed layer beneath it. After the PbSCC test, this deformed surface layer had oxidized, resulting in an Cr-Fe-enriched oxide containing Pb. In addition, “islands” of Ni metal were observed within the oxidized layer, Fig. 1. In contrast, localised attack in the form of corrosion slots containing Cr₂O₃ (Fig. 2) was observed on the surface of the polished specimen. Electron diffraction and EBSD confirmed that these crystallographic slots formed along {110} planes and some {100} planes.

Figure 2. (a) SE image of post-PbSCC tested polished surface containing crystallographic slots (red lines); (b) TEM image of a corrosion slot; (c) [110] SADP with Cr₂O₃ in slot; STEM-EDX maps of (d) Ni K α (green), Cr K α (blue), and Fe K α (red), (e) O K α and (f) Pb M α .
