The Kolka-Karmadon rock/ice slide of 20 September 2002: an extraordinary event of historical dimensions in North Ossetia, Russian Caucasus

ABSTRACT. On 20 September 2002, an enormous rock/ice slide and subsequent mud-flow occurred on the northern slope of the Kazbek massif, Northern Ossetia, Russian Caucasus. It started on the north-northeast wall of Dzhimarai-Khokh (4780 m a.s.l.) and seriously affected the valley of Genaldon/Karmadon. Immediate governmental actions, available scientific information, first reconstructions, hazard assessments and monitoring activities as well as initial expert judgments/recommendations are documented in order to enable more detailed analyses and modelling of the event by the wider scientific community. Among the most remarkable aspects related to this event are (1) the relation between the recent event and somewhat smaller but quite similar events that occurred earlier in historical times (1835, 1902), (2) the interactions between unstable local geological structures and complex geothermal and hydraulic conditions in the starting zone with permafrost, cold to polythermal hanging glaciers and volcanic effects (hot springs) in close contact with eac

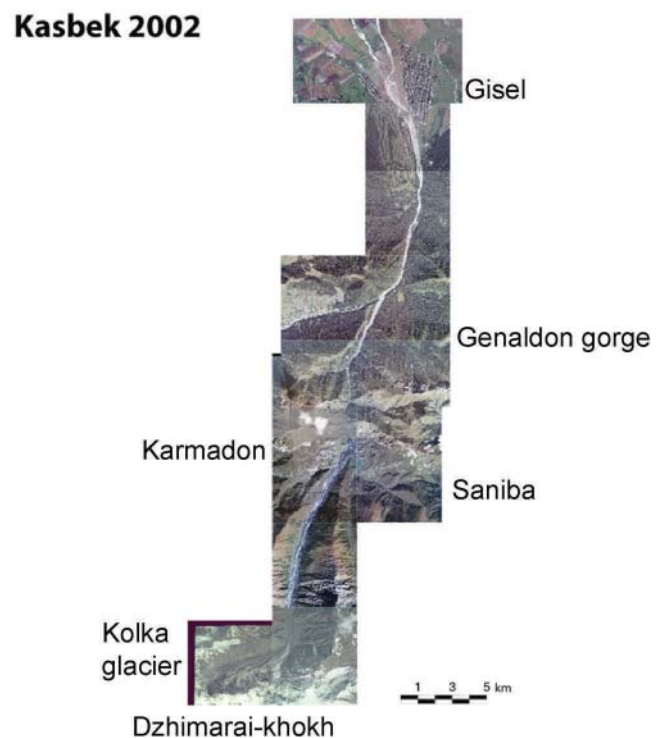
Fig. 1. Schematic map and situation after the event with names of most important sites. Quickbird image of 25 September 2002.

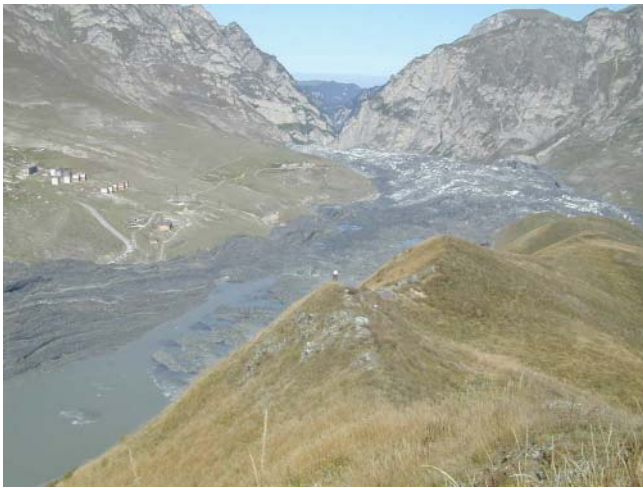
Fig. 2. Avalanche deposits at Karmadon. The overridden lower village and the former research station are at the lower left of the image; the partly inundated village of Gornaia Saniba is to the right (cf. Fig. 3). The entrance to the narrow Genaldon gorge, where the mud-flow started from the compressed avalanche, is in the upper centre of the image. Photo: I. Galushkin, 22 September 2002.

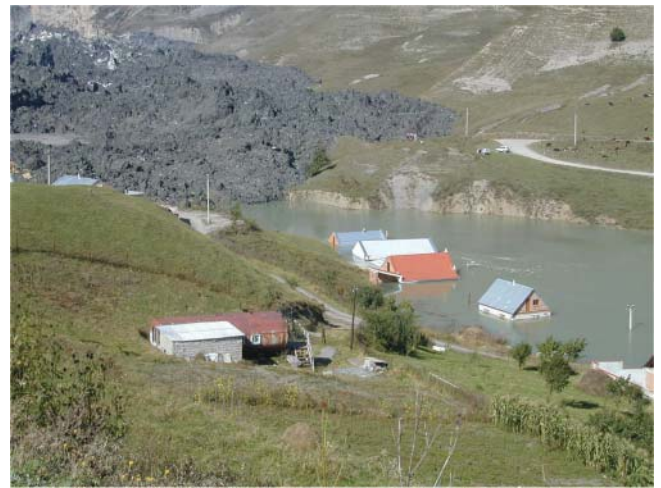
Fig. 3. Drowned houses in the lake dammed by the avalanche at Gornaia Saniba. Photo taken by Ministry of Natural Resources, North Ossetia, 25 September 2002.

The ice/debris masses deposited by the slide at Karmadon began to dam river flow and led to the formation of several lakes after the slide. The largest lake developed at the settlement of Saniba at the southeast end of the ice dam. As soon as 5 days after the slide, the lake had an area of $192\,000\text{ m}^2$ according to QuickBird satellite data. The maximum size of the lake was reached by 20 October 2002, with an estimated volume of $\sim 4\text{--}5 \times 10^6\text{ m}^3$ (cf. Kääh and others, 2003b). The rising lake level flooded numerous houses at Saniba. Additionally, several lakes of variable size formed at the left (western) margin of the ice/debris dam.

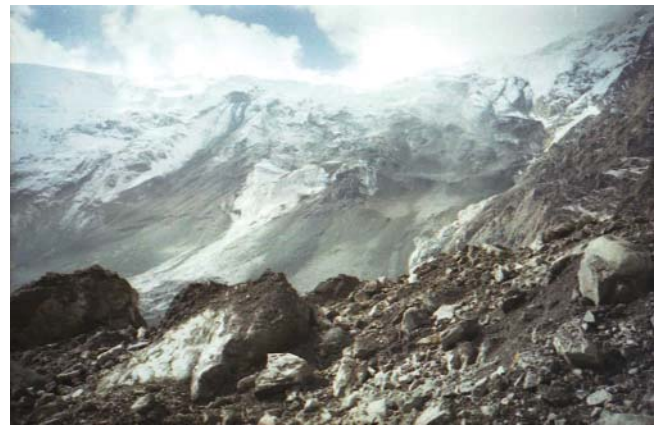
Fig. 4. Surface of Kolka glacier and north-northeast wall of Dzhimarai-Khokh a few days before the event. Traces of strong ice- and rock-fall activity within the lower part of the wall are clearly visible. Photo taken by a group led by A. Falin.

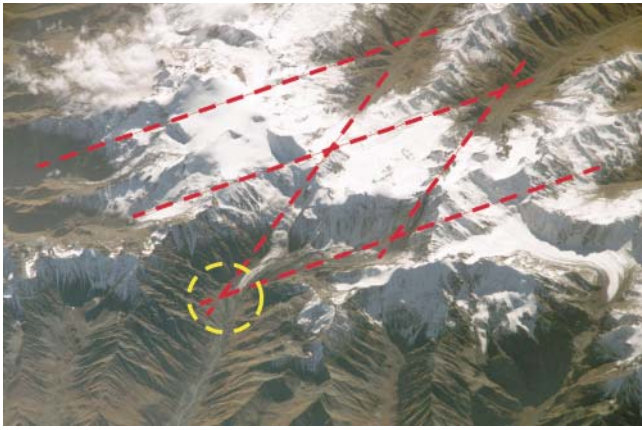
Fig. 5. Oblique view to the Kazbek massif with approximate direction of major faulting (red dashed and dash-dotted lines) and hot-spring area (yellow circle) indicated. International Space Station–Russian Program Uragan, 17 October 2002.

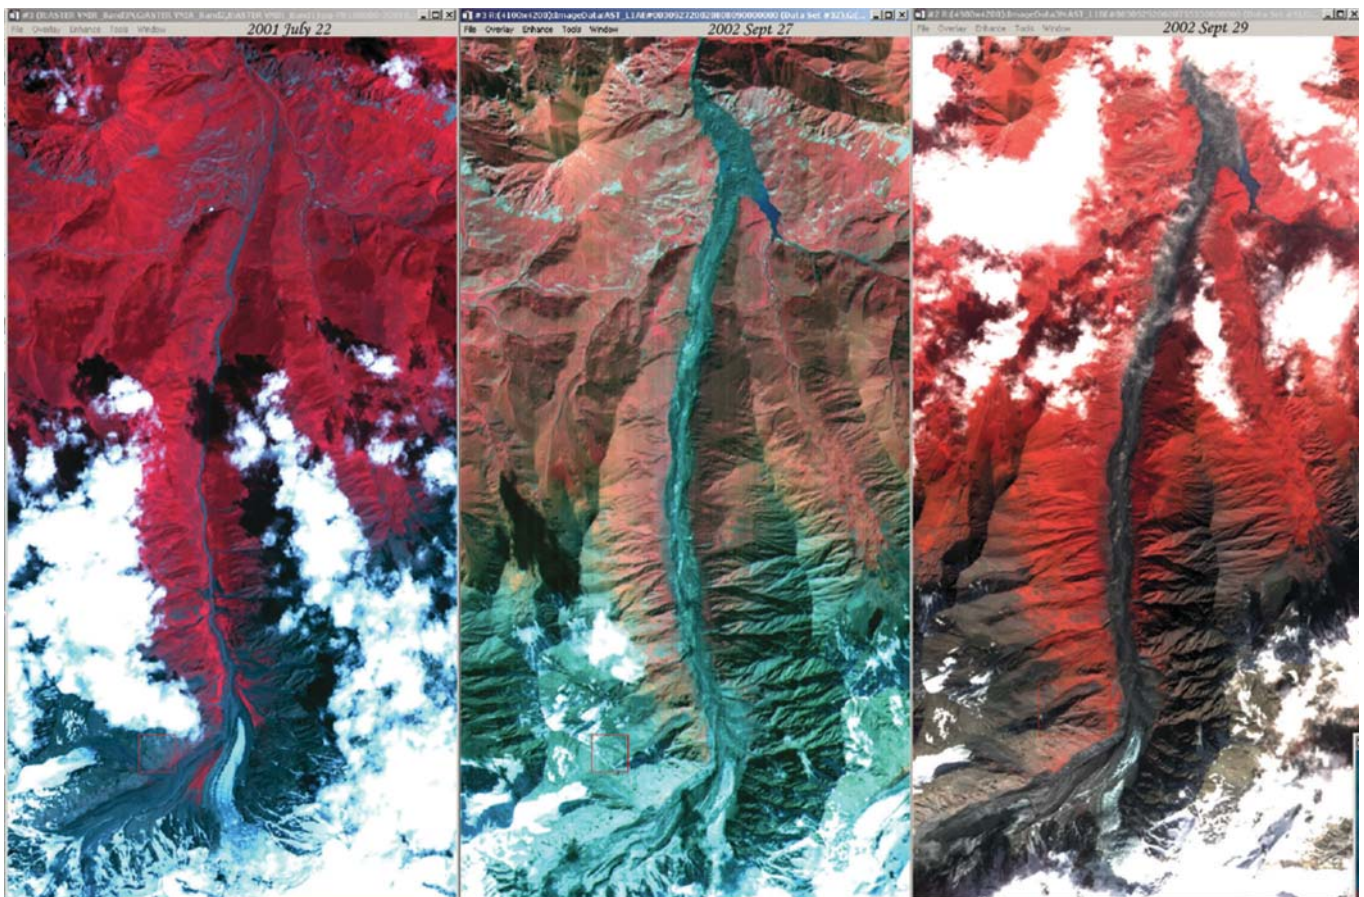
Fig. 6. ASTER images of 22 July 2001, 27 September 2002 and 29 September 2002, showing the avalanche path before and after the event.

Difficult access conditions to the event starting zone and poor current topographic information suggested the use of satellite imagery for event reconstruction (Figs 5–7). High-resolution satellite sensors such as the Landsat-7 Enhanced Thematic Mapper Plus (ETM+; 15 m ground resolution for panchromatic band) and the Advanced Spaceborne Thermal Emission and Reflection Radiometer (ASTER; 15 m ground resolution for visible and near-infrared bands (VNIR)) support recognition of important indicators of glacier-related hazards (e.g. avalanche and debris-flow trajectories, glacier crevasses and glacial lakes). In particular, ASTER has proved to be very suitable for assessing glacier hazards (Kääb, 2002; Wessels and others, 2002; Huggel and others, 2003; Kääb and others, 2003a). Thanks to their along-track stereo capability, ASTER data allow us to generate digital elevation models (DEMs) (Kääb, 2002;

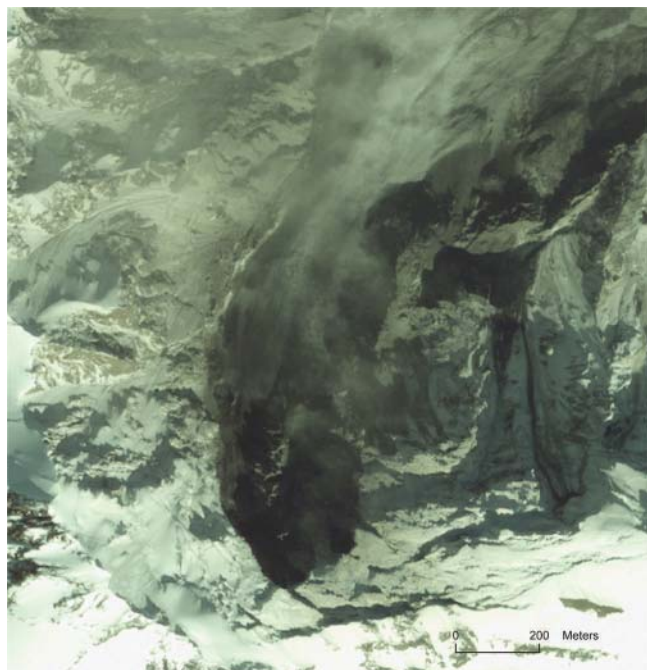
Fig. 7. Detail of the detachment zone from QuickBird image of 25 September 2002. Note black traces of rock instability to right of the dark starting zone of the main event.

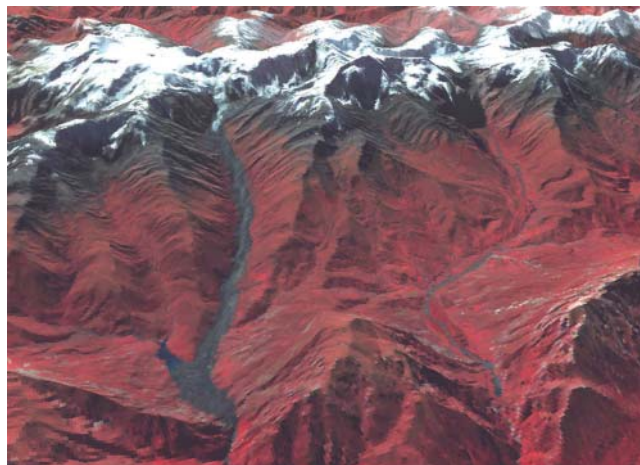
Fig. 8. ASTER scene of 6 October 2002, channels 1, 2 and 3N, combined with ASTER DEM from the same image; resolution resampled from 30 to 15 m. Satellite data provided by Global Land Ice Measurements from Space (GLIMS), US Geological Survey/NASA.

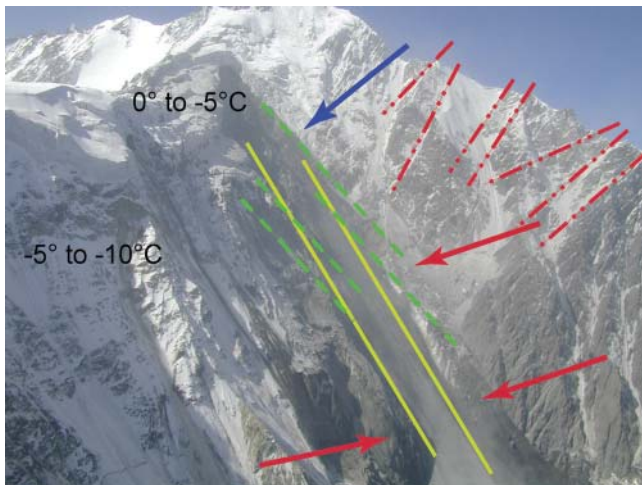
Fig. 9. Starting zone of the Kolka-Karmadon rock/ice slide in the highest part of the north-northeast wall of the summit of Dzhimarai-Khokh (blue arrow points to vertical cut through hanging glacier and bedrock). The general dip of the layering within the metamorphic rocks is indicated with green dashed lines, two general directions of fracturing with red dash-dotted lines, the inclination of the main slope and failure plain with yellow lines. With the general slope cutting through the less steep layering, unsupported outcrops of steeply inclined rock layers formed (red arrows). Temperature indications refer to exposed rock surfaces/vertical ice cliffs and to firn surfaces of hanging glaciers. Photo: I. Galushkin, 25 September 2002.

The slide starting zone (shown in Fig. 9) was located between about 4300 and 3500 m a.s.l. Approximately $4 \times 10^6 \text{ m}^3$ of steeply inclined metamorphic rock layers were detached in the upper part of the slope to about 40 m depth, entraining a similar thickness/volume of snow, firn and glacier ice. A system of fissures cuts through the bedrock layers, and the slope of a dip in these layers, as visible in the detachment zone after the event, was less than the inclination of the now exposed surface. In fact, the resulting unsupported outcrops of steeply inclined bedrock layers in the lower part of the affected slope (arrow in Fig. 9) could have constituted an important geological influence on stability conditions. In any case, the primary cause of the instability must have been within the bedrock rather than in the surface ice. In view of the fact that bedrock stability in cold mountain areas can be especially low in warm or degrading permafrost (Davies and others, 2001), thermal

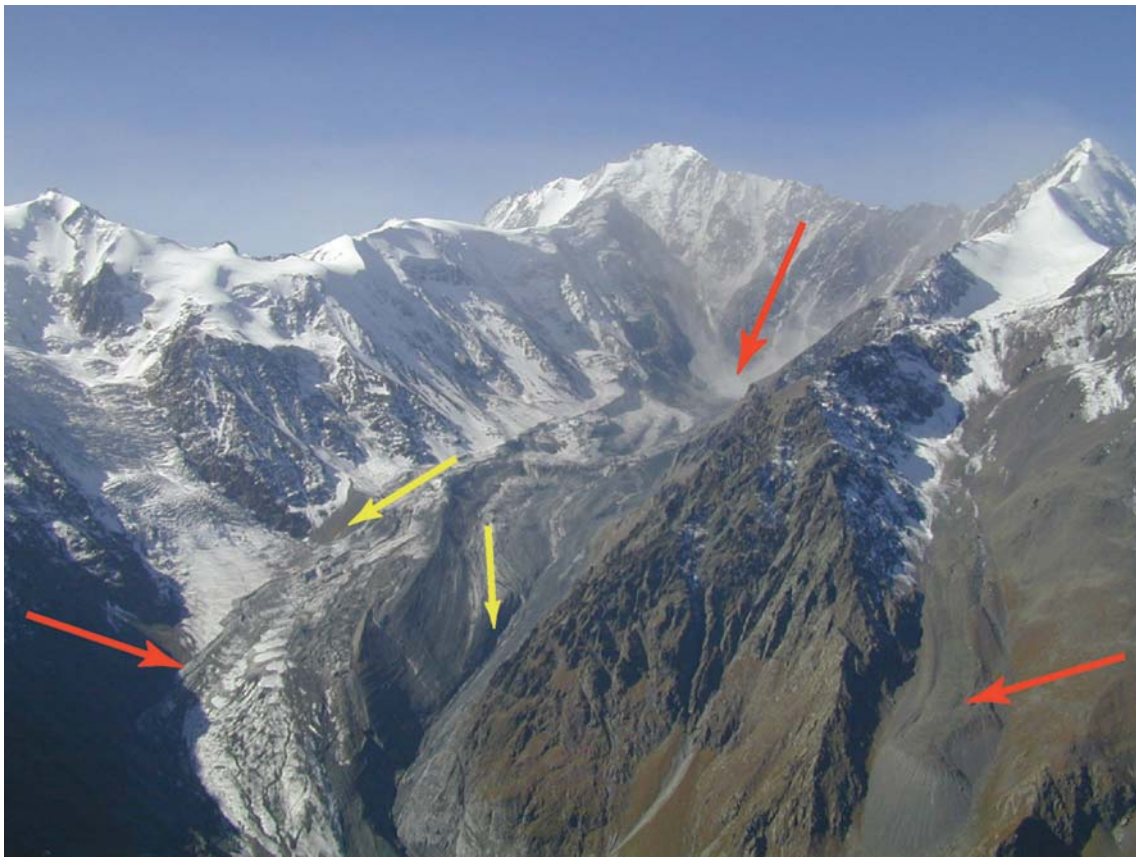
Fig. 10. Upper avalanche path of the Kolka-Karmadon rock/ice slide. The summit of Dzhimarai-Khokh and the detachment zone are in the background; Kazbek volcano is to the left (outside the image). Red arrows point to active talus-derived rock glacier in the lower right corner, steam (?) or dust (?) cloud at the foot of the slope where Kolka glacier has been sheared off and overridden the tongue of Maili glacier. Flow directions of two different and subsequent flow phases are indicated with yellow arrows. Photo: I. Galushkin, 25 September 2002.

very high speed but without strongly eroding its relatively clean ice (Fig. 10). The main, and probably less liquid, mass followed at slightly lower speed along the inside of the right lateral moraine (6 in Fig. 11) towards the left valley slope again. After passing the gap between the right lateral moraine of Kolka glacier and the left lateral moraine of Maili glacier, temporarily dammed distal parts of the debris flow on the external moraine side started flowing across the track of the main mass (7 in Fig. 11), clearly indicating that the two main flow phases were intimately coupled.

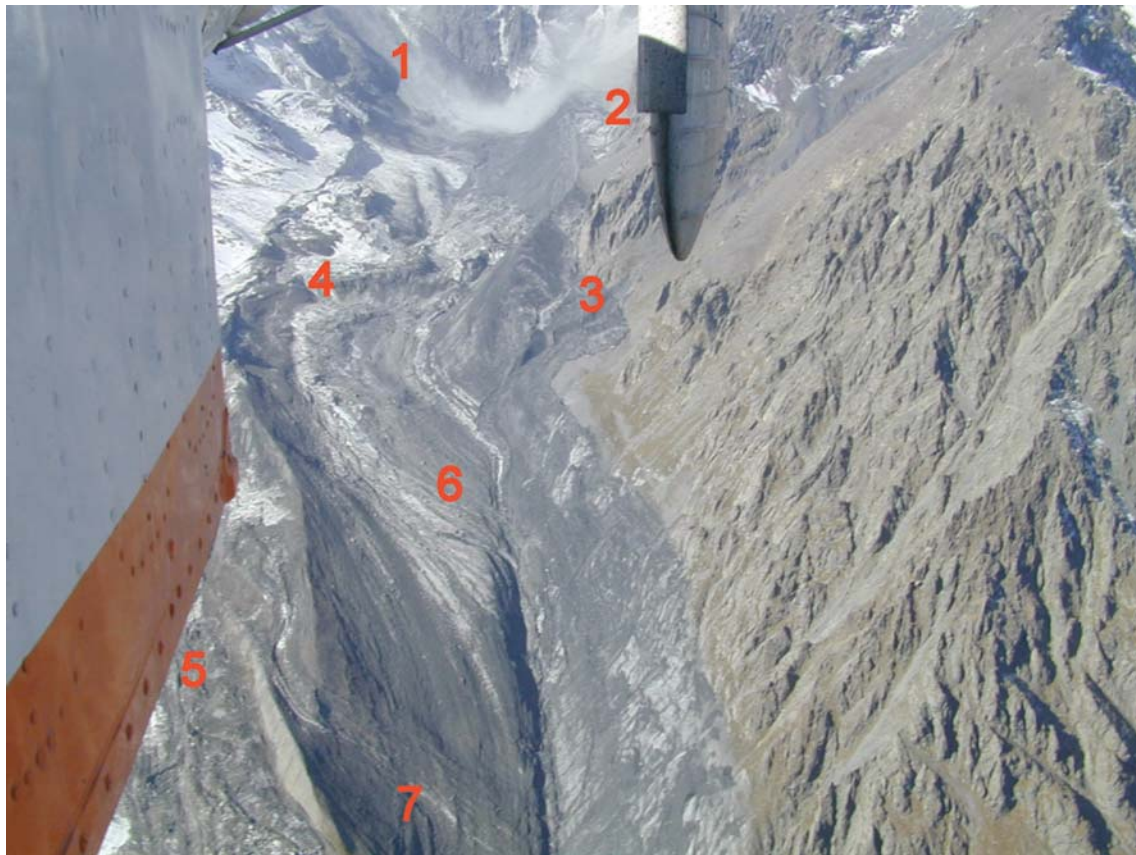
20 September 2002 had a drop height of 900–1000 m before impacting Kolka glacier which slopes away from the bottom of the Dzhimarai-Khokh north-northeast wall over a length of 3 km at an inclination of about $5\text{--}10^\circ$. The impact event resulted in erosion and complete displacement of (a roughly estimated) 60–75% ($\sim 80 \times 10^6 \text{ m}^3$) of the mass of Kolka glacier to 40–60 m depth (data provided by Petrakov and others (2004) from comparison with earlier photographs). Thus, the glacier was detached along a line parallel to the foot of the Dzhimarai-Khokh wall, leaving a pronounced scar (Fig. 10), and pushed (upwards) towards its left lateral moraine and in the down-valley direction (Fig. 11).

Fig. 11. Impact zone where Kolka glacier was eroded. Numbers refer to important parts of the triggering mechanism (cf. text): 1. main impact from wall; 2. ice debris thrown across left lateral moraine; 3. first (minor) splash of mud at lower end of left lateral moraine; 4. start of swing-like flow of the main mass due to deflection at left- then right-lateral moraine of Kolka glacier; 5. second (large) splash of mud forming fast mud/debris flow outside the right lateral moraine of Kolka glacier and across the tongue of Maili glacier; 6. slightly slower flow of main mass along inside of right lateral moraine; 7. temporarily blocked distal parts of fast mud/debris flow (5), crossing gap between right lateral moraine of Kolka glacier and left lateral moraine of Maili glacier and flowing across traces of main mass after its passage. Photo: I. Galushkin, 25 September 2002.

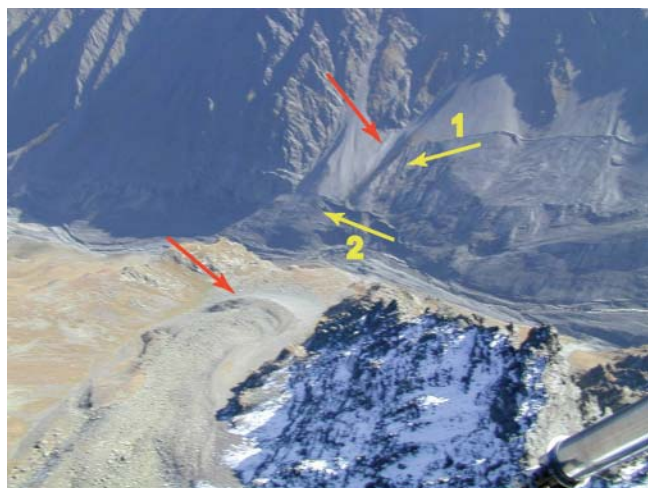
Fig. 12. Site (below Maili glacier) of the main turning to the left of the avalanche mass. Red arrows point to scree slopes and active rock glacier; yellow arrows indicate traces of two different and subsequent (1 then 2) flow phases with different super-elevation in the external part of the turn, reflecting higher (1)/lower (2) flow velocity. Photo: I. Galushkin, 25 September 2002.

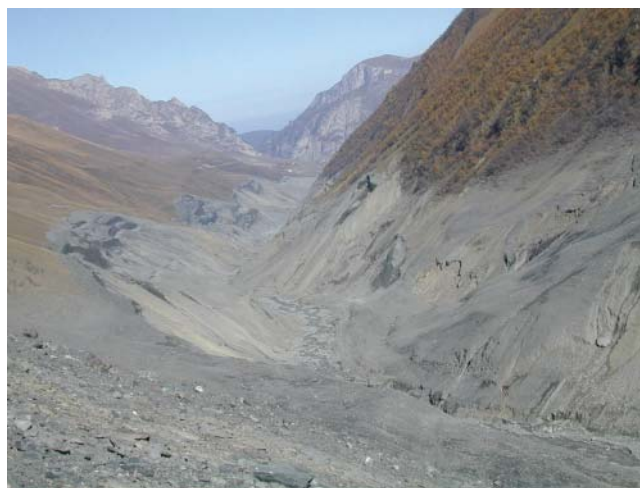
Fig. 13. Waveform traces of avalanche motion along path towards Karmadon. Photo: I. Galushkin, 19 October 2002.

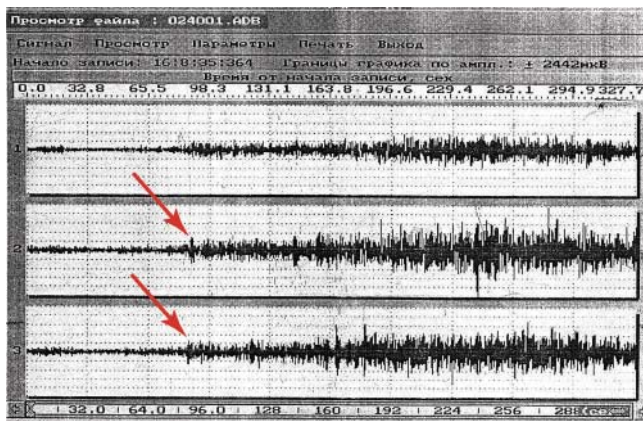
Fig. 14. Seismic record: 20 September 2002, 16:08:35, station 'Fiagdon', Geophysical Center for Experimental Diagnostics, Russian Academy of Sciences. Arrows point to possible signals of low-angle impact on Kolka glacier. Detailed analysis from several stations seems to be difficult and is not yet available (cf. contribution by V. Zaalishvili and N. Nevskaya in GRNO-A, 2004).

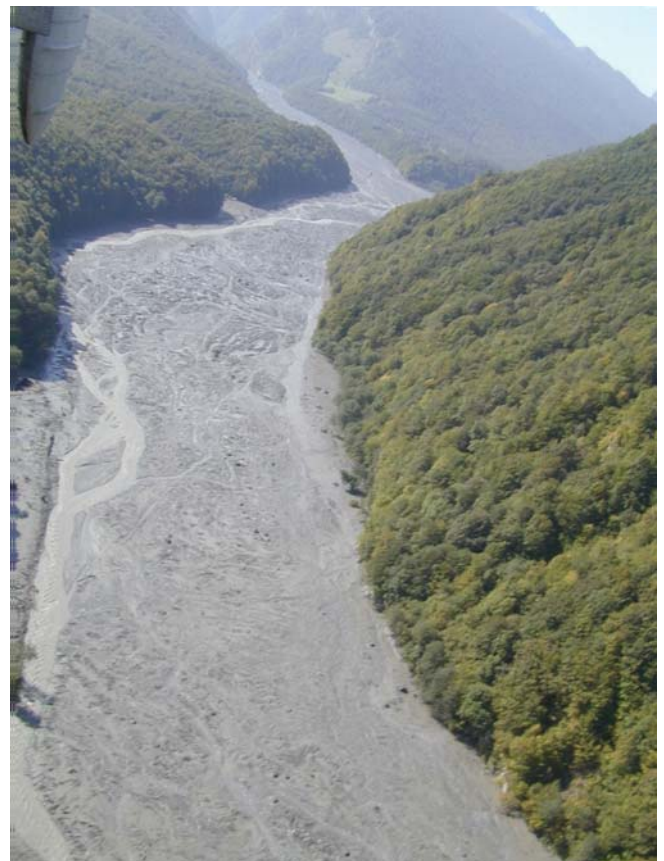
Fig. 15. Mud-flow below the Genaldon gorge. Note completely covered river bed, eliminated forest stands and buried access road. Photo: I. Galushkin, 25 September 2002.

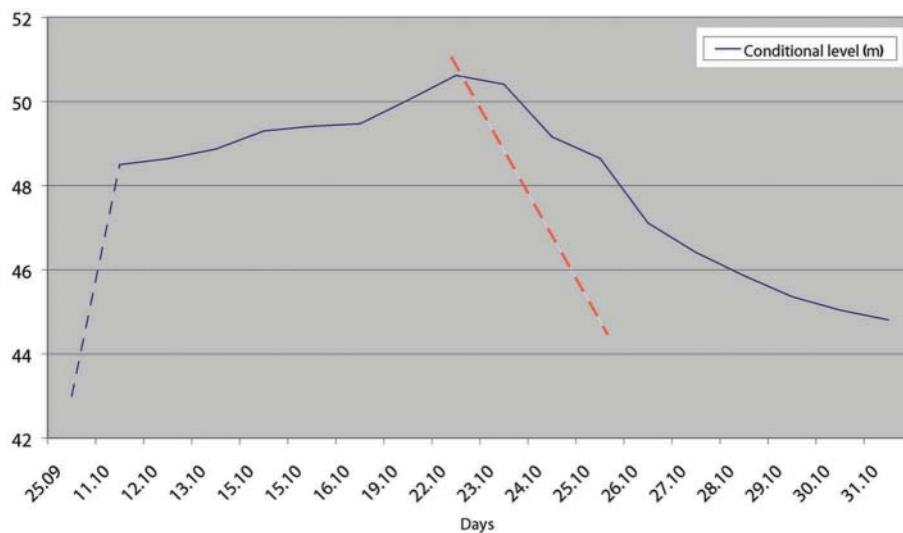
Fig. 16. Changes in lake level recorded at Gornaia Saniba. The red dashed line indicates critical rate of level change as defined for possible beginning of outburst and initiating alarm concept in down-valley settlements.

As there was no way to observe the ongoing processes within and under the ice/debris dam, the monitoring concept was based on control of inflow to, and outflow from, the ice/debris dam. Outflow measurements at the lower end of the dam itself were complicated due to the inaccessibility of the area in the gorge (frequent ice- and rock falls). Discharge measurements had therefore to be made some kilometres further downstream. Saniba lake, however, was under continuous observation. A constant lake level rise was measured in the period 20 September–22 October 2002. In order to assess a sudden discharge from Saniba lake and potential downstream flooding effects, a critical threshold of the rate of lake lowering was determined. The threshold was set at 0.1 m h^{-1} as this would roughly double the observed discharge and most likely mark the beginning of a potentially dangerous outburst process. If the threshold was exceeded, or discharge became suddenly blocked, a series of control and safety procedures were to be

activated (including the possible evacuation of inhabitants of Gisel to more elevated ground). Activation of such procedures was not necessary. A moderate drop in the level of Saniba lake began after 22 October 2002, by natural formation of drainage channels (Fig. 16). Emergency interventions at the ice/debris dam, such as channel excavation or even dam destruction by explosives, were disregarded after careful evaluation, mainly due to inefficiency in relation to the enormous dam dimensions.

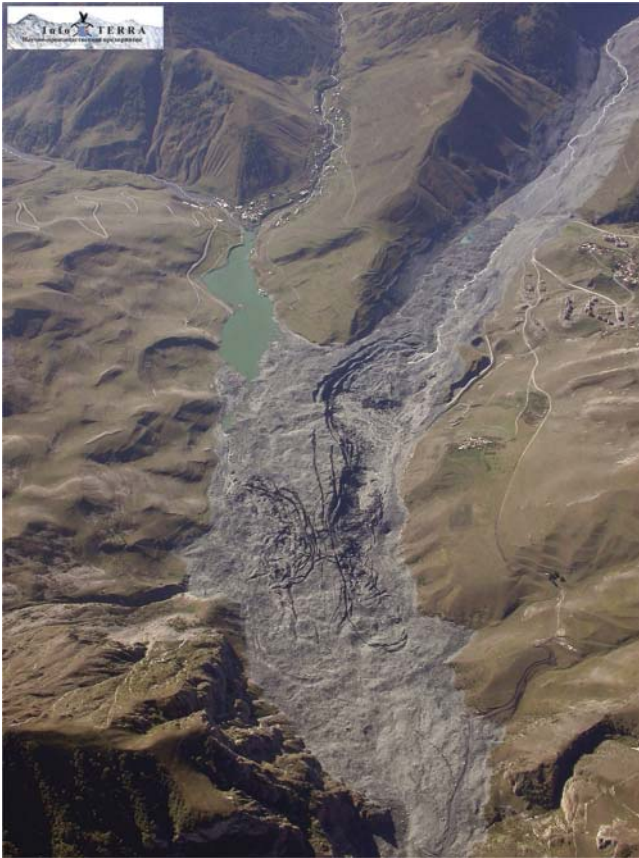
Fig. 17. Collapse structures in avalanche deposit in fall 2003. Photo: I. Galushkin, 23 September 2003.
