## Adiabatic Shear in Ordnance Components and Threaded Connections

F.E. Schmidt<sup>1</sup>, M.A. Hineman<sup>1</sup>, and J.D. Fuerst<sup>1</sup>

<sup>1</sup> Engineering Systems Inc., Aurora, IL

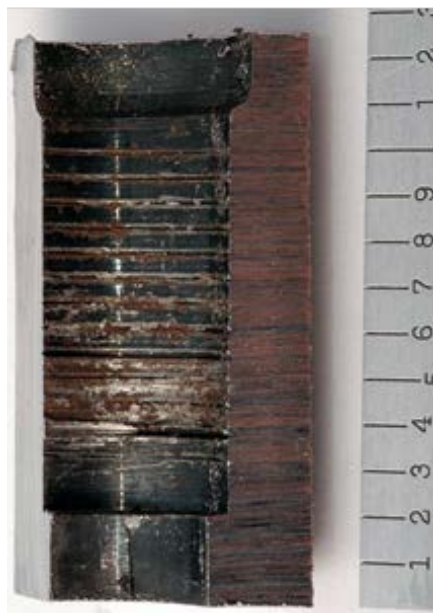
**Figure 1:** Section of threaded steel region with threads 1-14, top to bottom.

The allegation in these joint failures is that the shape, size or metal working has been performed improperly. Figure 1 shows a 14 thread inside diameter profile from rifling (narrow) end to the wider breech end. The same consideration exists for screw-in barrels/receiver configuration, Knoop micro-hardness measurements were made at a fixed distance below all 14 thread roots. Figures 2 - 4 show the microstructural profiles. Table 1 indicated two independent test labs reported a uniform hardness and Figures 5 - 7 illustrate the white martensite phase.

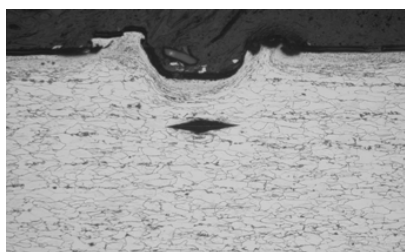
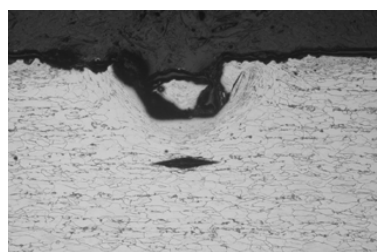
**Figures 2 – 4:** Cross sections of profiles of threads #3, #8, and #14 (original magnification 100x).

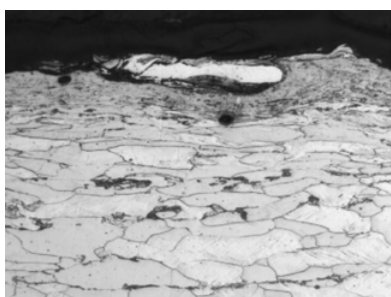
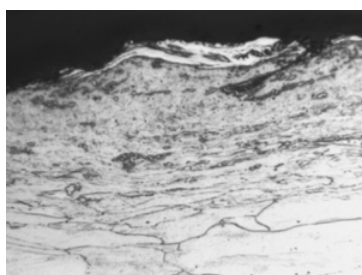
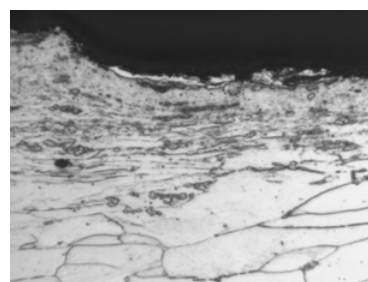
**Figures 5 – 7:** Cross sections showing white adiabatic shear regions as white areas near the surface at original magnifications of 400X (left) and 1000X (center and right) between thread locations 13-12, 11-10, and 10-9, respectively.

The identification of intense “adiabatic” shear bands was found across the three visual and wear debris topographical inside diameter surfaces. The etchant used was 2%Nital with the testing repeated twice by grinding back the cross sectional profile. Figures 5 - 7 illustrate the “white martensitic” layer observed in all three regions of the threaded connection failure.

Threaded connections that experience dynamic explosive strain rates can exhibit adiabatic shear bands if the intensity and localization of the shearing forces reach the threshold concentration to induce dynamic shear. The formation of “white martensite”, while difficult to identify is conclusive and was not the result of metal transfer from the adjacent stainless steel.
