Removal of Humic Acid from Natural Water by ZVI/H₂O₂ Process

NO Santos¹, JC Spadotto¹, MG Burke², IG Solórzano¹, LC Campos³ and LAC Teixeira¹

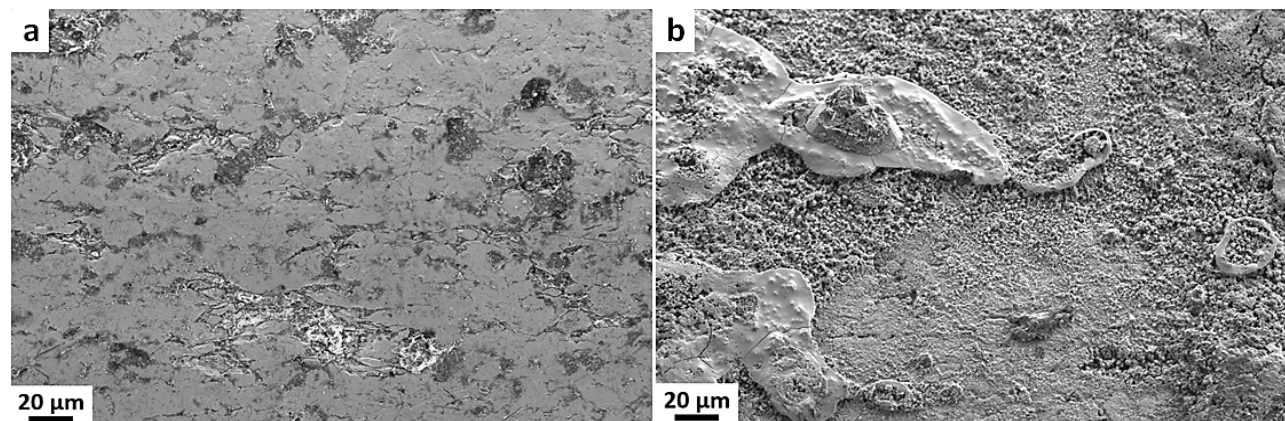
Figure 1. SE images of iron cuts surface. (a) as-received condition and (b) post-ZVI/ H_2O_2 in 75 minutes of reaction.

The secondary electron (SE) SEM image in Figure 1a shows the ZVI surface in the as-received condition (before the ZVI/H₂O₂ reaction). Figure 1b shows the ZVI surface after the ZVI/H₂O₂ reaction. This SE image revealed the presence of oxides that formed on the metallic Fe surface. These oxides confirm that oxidation of ZVI by the H₂O₂ had occurred in the solution as described by Eq. (1). As expected in this oxidative process, metallic Fe is oxidized by H₂O₂ to form ferrous iron, releasing ions into solution which subsequently react with H₂O₂ to produce a highly reactive radical (·OH) for the degradation of the organic matter (Eqs. (1 – 3)). Thus, a significant difference in oxidation is evident from the different oxide morphologies between Figures 1a (as-received native oxide on Fe prior to exposure) and 1b (after the ZVI/H₂O₂ process) confirming the oxidation mechanistic step of the ZVI/H₂O₂ process. Figures 2a and 2b show the formation of oxides with heterogeneous morphologies on the ZVI surface after the ZVI/H₂O₂ process. In Figure 3a the coexistence of two different morphologies can be observed in the same region. These different morphologies may be due to pH variation during the reaction, producing a variety of stable iron oxides. The LV SEM-EDX elemental maps confirming the presence of oxygen in the near-surface region of the exposed Fe specimens are presented in Figures 3b and 3c.

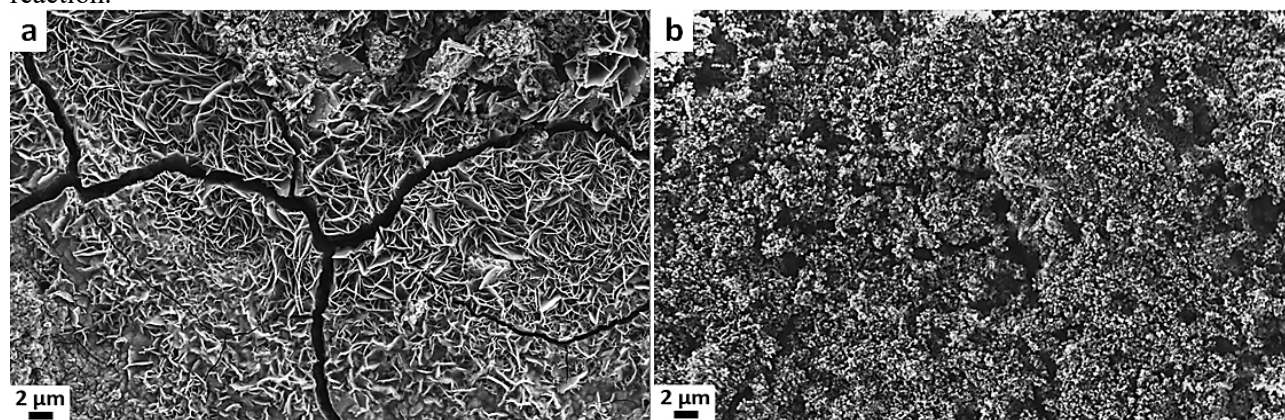
Figure 2. SE images of oxides on the Fe sample surface post-ZVI/ H_2O_2 in 75 minutes of reaction.

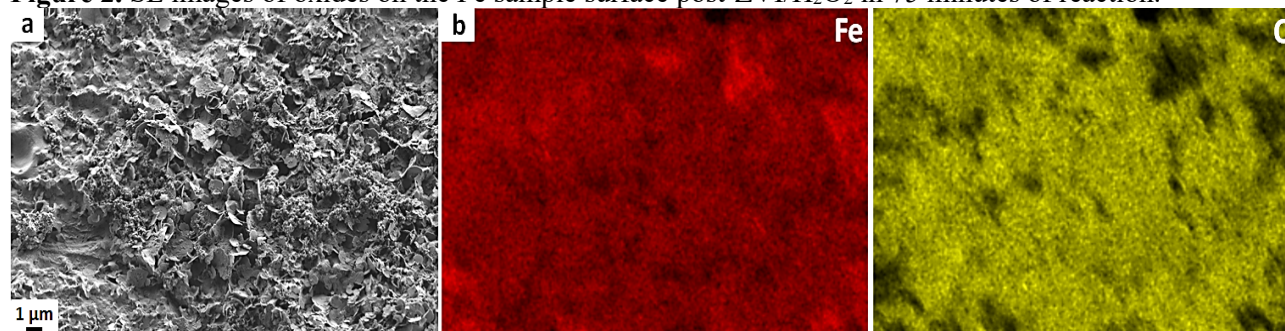
Figure 3. (a) SE image of oxidized Fe surface post-ZVI/ H_2O_2 process; (b) complementary LV EDX maps of Fe and O.
